**EXPEDITED SITE-WIDE RI/FS TASK
BUILDING 1 EAST WING AMMONIA INVESTIGATION
SUMP AND SOIL CHARACTERIZATION**

**HARLEY-DAVIDSON MOTOR COMPANY OPERATIONS, INC.
YORK VEHICLE OPERATIONS
1425 EDEN ROAD
YORK, PENNSYLVANIA 17402**

JUNE 2005

**BUCHART-HORN, INC.
CONSULTING ENGINEERS AND PLANNERS
445 WEST PHILADELPHIA STREET
P.O. BOX 15040
YORK, PENNSYLVANIA 17405-7040**

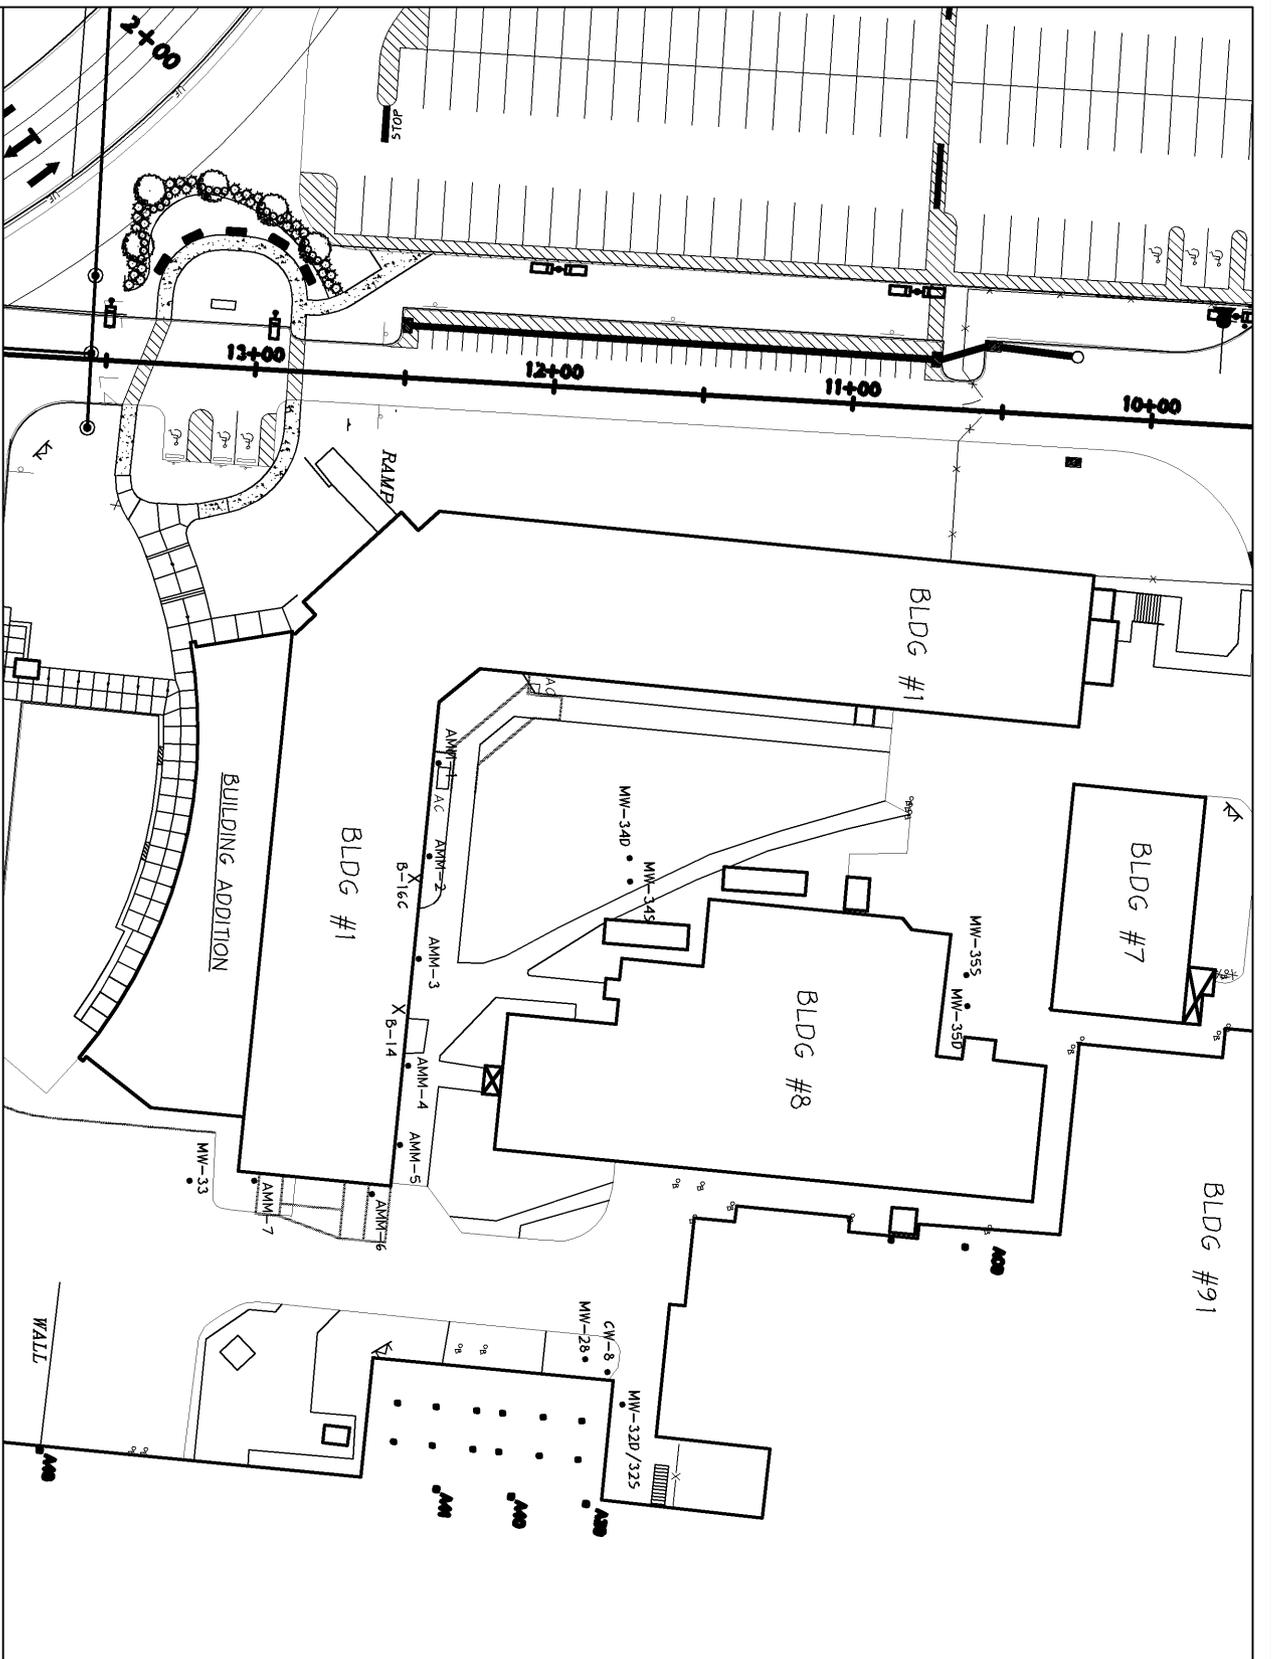
FIGURE 2
SAMPLE LOCATION PLAN
BUILDING 1 - EAST WING AMMONIA INVESTIGATION
HARLEY-DAVIDSON MOTOR COMPANY OPERATIONS, INC
1425 EDEN ROAD
YORK, PENNSYLVANIA

Seven soil probes (AMM-1 through AMM-7) were advanced along the north and northeastern perimeter of the East Wing of Building 1. Samples were analyzed for pH, Ammonia, Nitrate, Nitrite, and TKN. None of the samples exceeded applicable Statewide Health Standards. In addition, none of the samples appeared elevated as compared to other samples.

The investigation documented in the report surrounded the area of concern. As the samples did not show significant contamination, it appears that the ammonia contamination is a small scale, localized problem. The storage tank previously used to store ammonia has reportedly been removed; therefore, there should no longer be an active source of ammonia in the area. Based upon the historical information available for review and the results of this investigation, it appears likely that the contamination exists as a localized problem beneath Building 1's concrete floor slab.

Based upon the results of this investigation, it has been determined that a Remedial Alternatives Study is not necessary at this time. BH does however recommend that a “Phase II” soil sampling investigation should be conducted below the concrete slab in the basement of Building 1 to further delineate ammonia contamination. The investigation would be focused in the eastern end of Building 1, in the area of the previous water infiltration. BH proposes that approximately ten borings, advanced to a depth of approximately 2-3 below the slab surface, should be sufficient to adequately evaluate the subfloor soil conditions in the basement of Building 1. If groundwater is encountered in any of the borings, samples of the water would also be submitted for laboratory analysis. A “Phase II” Soil Investigation work plan showing the proposed boring locations, will be prepared by BH.

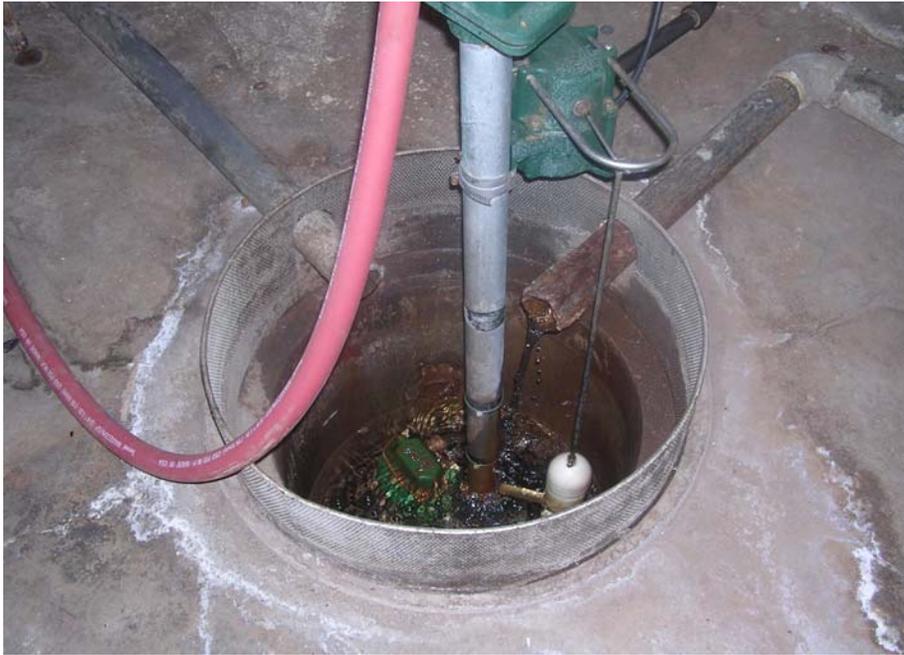
Sump:	B-14	B-16C
Total Depth:	28.5"	48"
Width:	21.5" Diameter (round)	42" x 33"
Construction Material:	Concrete	Concrete
Depth to Water:	14" from surface	25" from surface
Volume of Water:	22.8 Gallons	138.0 Gallons
Presence of Solids?	Yes - less than 1/8 inch	Yes - less than 1/8 inch
Total Amount of Solids?	Less than 10 cubic inches	Less than 10 cubic inches
pH	8.86	9.15
PID Readings	3.1 ppm	0.0 ppm
Ammonia Concentration:	0.0 ppm	0.0 ppm
Comments:	Solid Bottom/no odors/no sludge at bottom	Solid Bottom/no odors/no sludge at bottom

Laboratory results indicated minor concentrations of nitrate in both of the sumps. In addition, a minor amount of ammonia was detected in sump B-14. This water is not potable in nature and does not directly contact Harley-Davidson personnel. Therefore, these minor concentrations are not considered a health risk or concern.

PHOTO 1 – VIEW OF SUMP B-14 LOOKING NORTH, LOCATED WITHIN THE BASEMENT OF BUILDING 1, EAST WING.

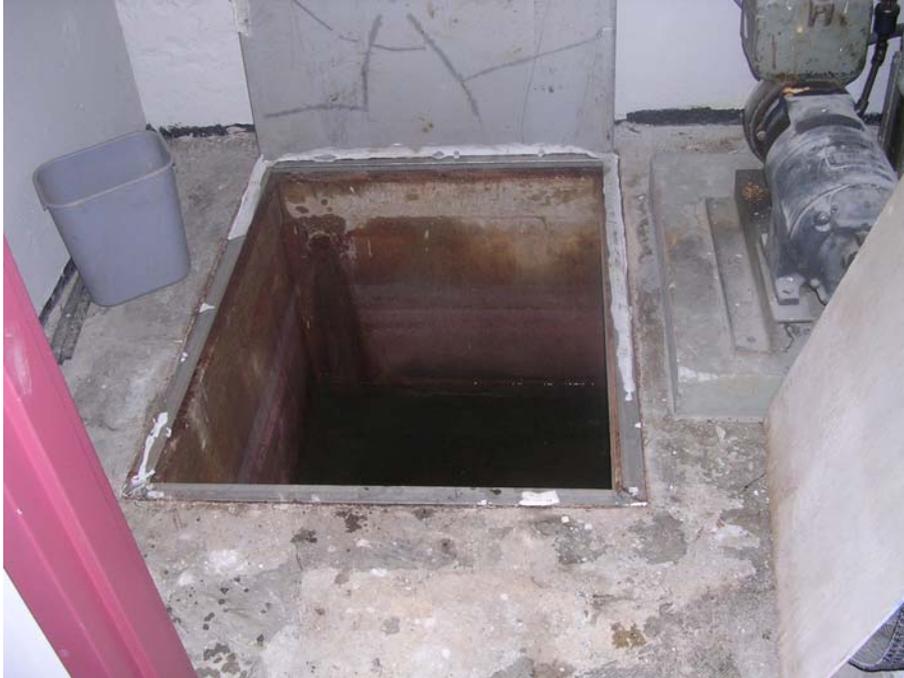
PHOTO 2 – VIEW OF SUMP B-16C LOOKING EAST, LOCATED WITHIN THE BASEMENT OF BUILDING 1, EAST WING. THE WATER ENTERING THE PIT IS CONDENSATE FROM SUMP B-14.

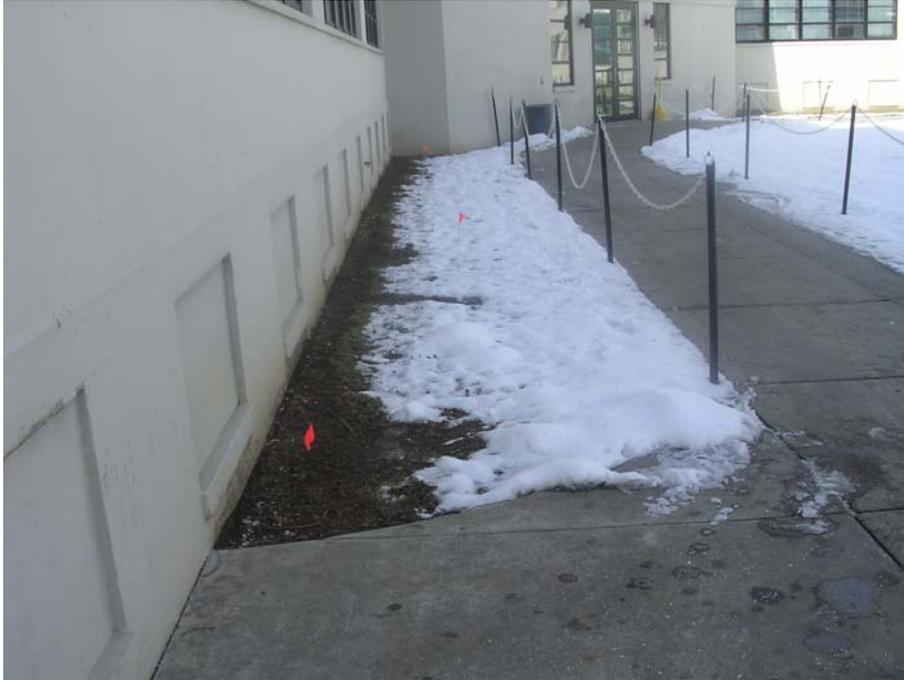
PHOTO 3 – BORING AMM-1 THROUGH AMM-5 LOCATED IN AREA BETWEEN SIDEWALK AND NORTH WALL OF BUILDING 1, EAST WING.

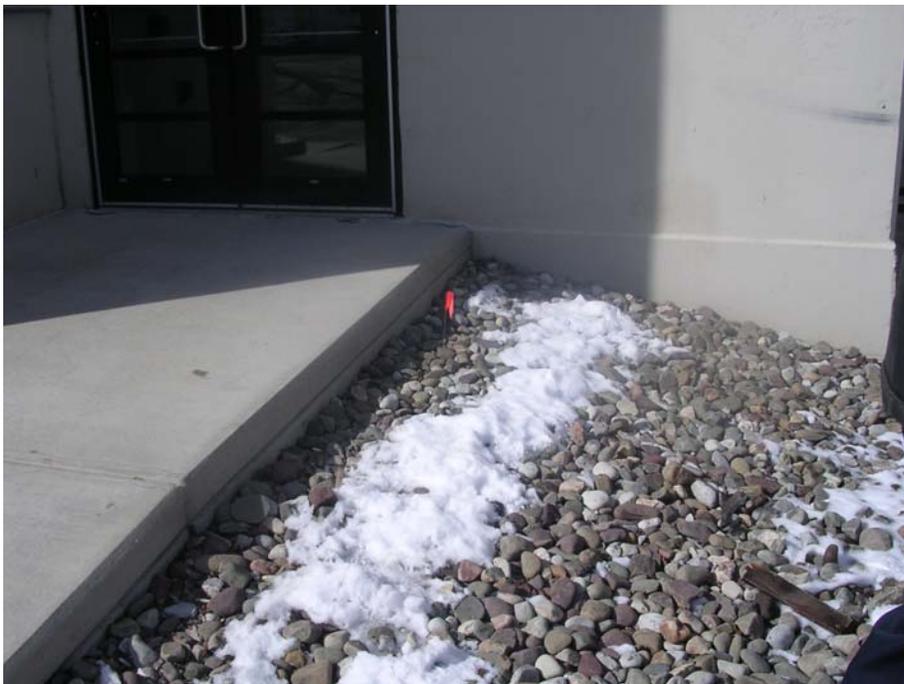
PHOTO 4 – BORING LOCATION AMM-6, LOCATED ALONG THE EASTERN WALL OF BUILDING 1, EAST WING. NO PHOTO AVAILABLE FOR AMM-7.
