**Final
BUILDING 57
SOIL INVESTIGATION AND BUILDING
CHARACTERIZATION PRIOR TO HAZARDOUS
WASTE STORAGE FACILITY USAGE**

SAIC Project 01-1633-00-6220-007

**Harley-Davidson Motor Company Operations, Inc.
York Vehicle Operations
1425 Eden Road, York PA, 17402**

April 2006

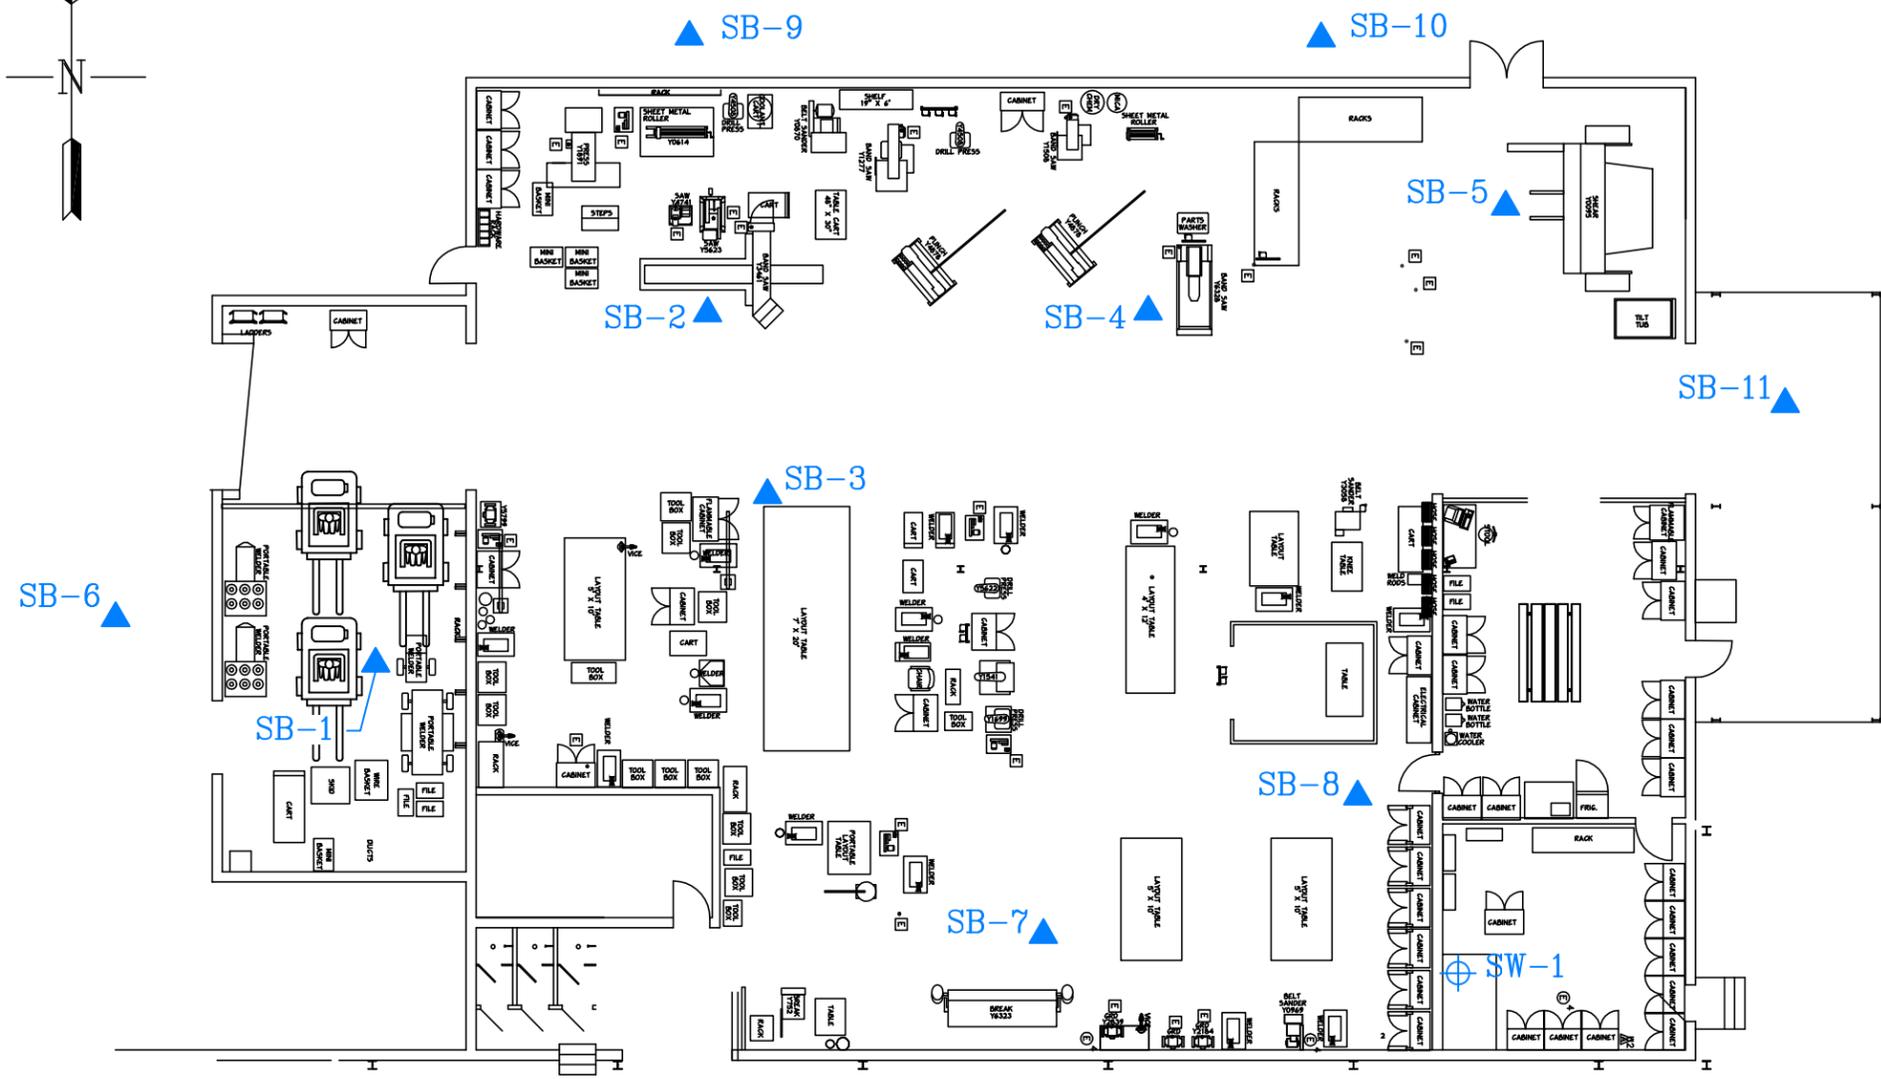
Twelve (12) soil samples were collected from the eleven (11) soil borings on February 21, 2006. These soil boring locations, seen on Figure 2, coincide with areas of historic or current environmental interest as described below:

- Boring SB-1, area formerly used for air conditioning equipment storage.
- Boring SB-2, area of oil-stained concrete near a band saw.
- Boring SB-3, area near a flammable materials storage cabinet.
- Boring SB-4, area of oil-stained concrete near a band saw and parts washer.
- Boring SB-5, area formerly used for paint storage and a paint booth.
- Boring SB-6 and SB-11, areas under the potential future location of a loading dock.
- Boring SB-7 and SB-8, closest accessible areas to the former tank and pit south of Building 57, and near current welding areas.
- Boring SB-9 and SB-10, between Building 57 and Building 51.

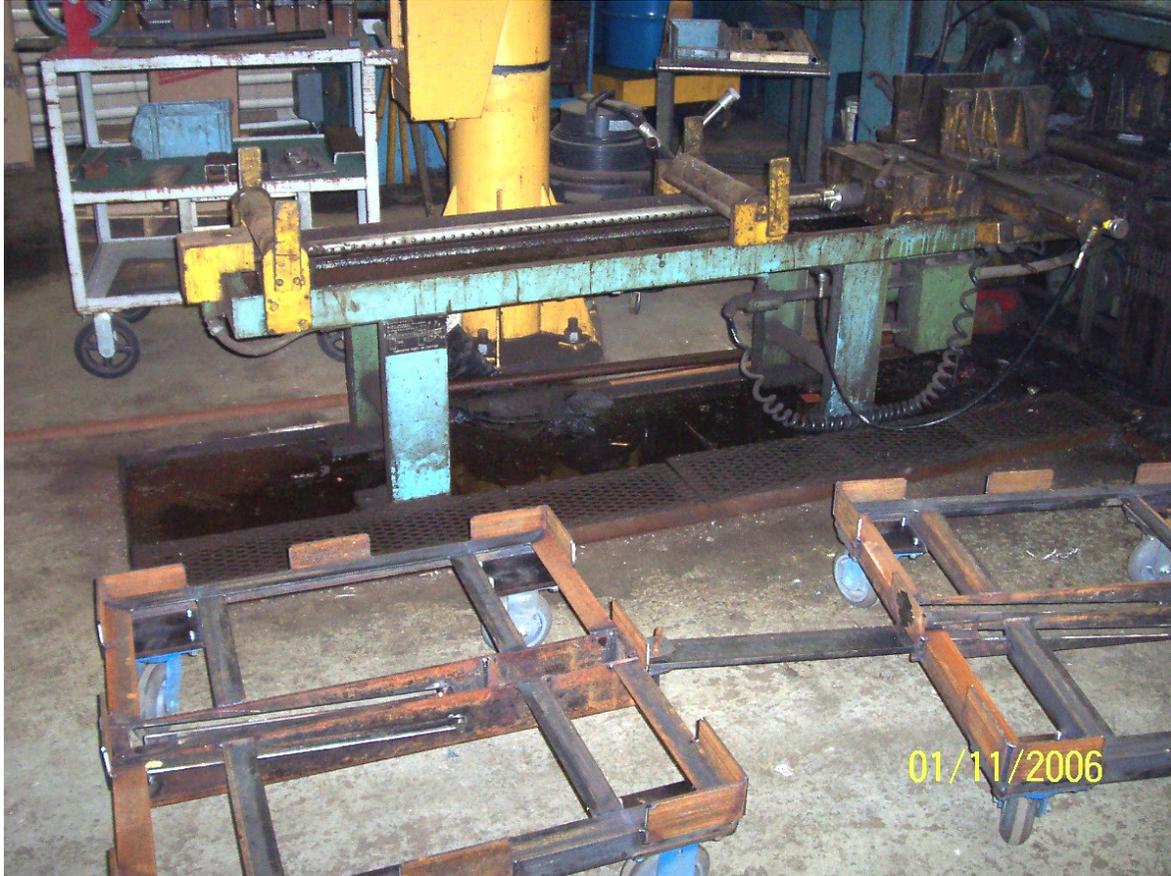
SAIC conducted a walk through of Building 57 on January 11, 2006. The walk through confirmed the location of work areas and equipment, as shown on Figure 2. Some oil stains were observed on the concrete floor around the two band saws and the parts washer in the north central portion of the building (see Photograph 1 in Appendix A, showing oil stains on the concrete floor around one of the band saws). The pit in the storage room was observed to be constructed of concrete block (painted and sealed) on two sides and poured concrete on the other two sides. The dimensions of the pit were 4 feet by 4 feet and 5½ feet deep. The bottom of the pit was concrete, except for a small recessed area in the northwest corner of the pit measuring 1½ feet by 2 feet and 6 inches deep, where water was observed. The bottom of this recessed area contained some silt covering what looked like a rock structure. Photograph 2 in Appendix A shows the current condition of the sump pit.

Photograph 1 – Oil stains on concrete under metal fabrication equipment in Building 57.

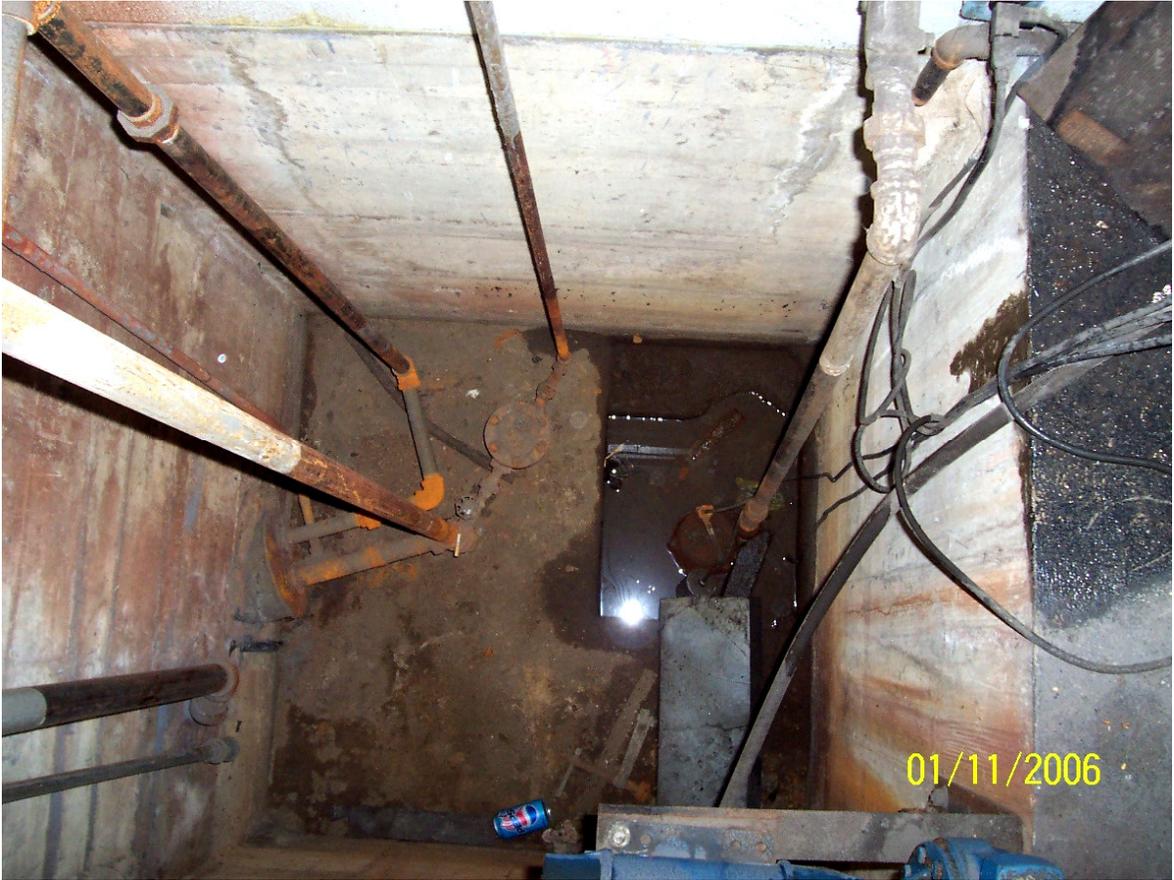
Depth to bedrock at these wells range from 37 to 63 feet below ground surface, with 17 to 45 feet of saturated overburden above bedrock. The direction of groundwater flow is generally toward the west-southwest. The water level observed in the Building 57 pit was found to be approximately 5 feet below ground surface and is not likely to be an expression of the groundwater table. If water infiltrates the Building 57 pit, it may be from a local perched groundwater condition.

According to the work plan, the original intention was to sample and test water from the pit in the storage room (labeled SW-01 on Figure 2). The water sample could not be collected since the pit was dry on February 21. Originally believed to be bedrock, the bottom of the recessed area appeared to be a concrete base. At this time the source of the intermittent water is unknown.

Photograph 2 – Concrete pit and sump pump in the southeast corner of Building 57.

The work plan called for the collection of a surface water sample from the pit during this investigation. That sample could not be collected on February 21, 2006 due to the pit being dry. SAIC recommends that this water sample be collected at a future date when water is available in the pit (usually during or directly after a rain event), and the information be included as an Addendum to this report.
