**INTERIM REMOVAL AND CLOSURE REPORT FOR
FORMER ELECTRICAL TRANSFORMER AREAS
FORMER YORK NAVAL ORDNANCE PLANT**

SAIC Project 2603100069

**Harley-Davidson
Motor Company Operations, Inc.
York, PA**

June 2012

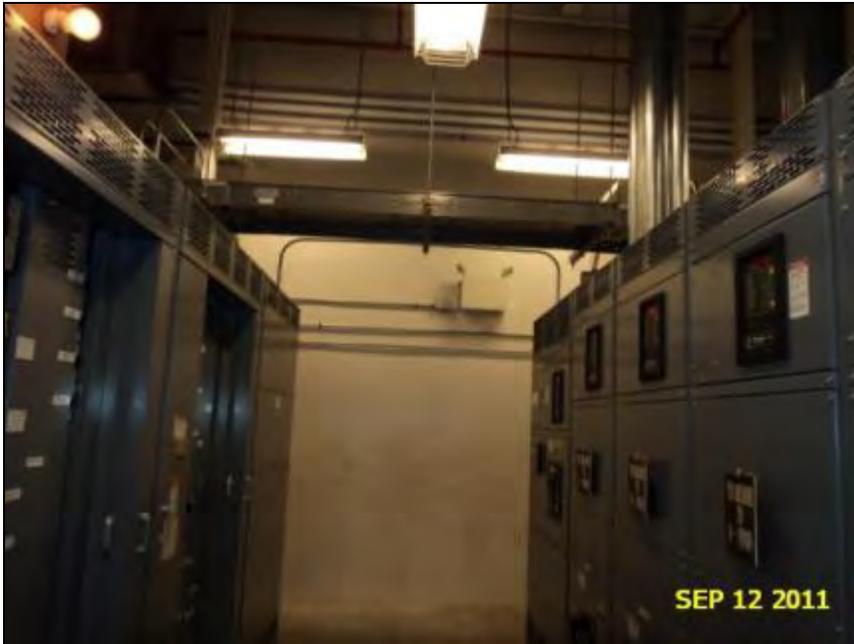
Aroclor-1260 was detected in samples collected from the lower portion of the east and south wall at B-Bank (ETAB-WC-002, -003, and -006) and from the lower east wall at C-Bank (ETAC-WC-003) at concentrations greater than the PADEP Clean Fill Limit of 30 mg/kg and the TSCA limit of 50 mg/kg. The Aroclor-1260 concentration in one sample (ETAB-WC-002) also exceeded the PADEP Regulated Fill Limit of 130 mg/kg.

A-3: Pre-Demo view inside B-Bank, looking south at south wall.

Prior to demolition activities, SAIC (the EI) marked the impacted concrete areas with red paint to allow for segregation of the impacted versus un-impacted demolition debris by the demolition contractor. Beginning in mid-December 2011, the B-Bank structure was demolished in stages to allow removal of salvageable electrical components, followed by demolition of the ceiling and walls, down to the impacted wall areas along the lower east and south walls. The un-impacted debris was segregated and removed first, leaving only the PCB-impacted concrete (see photos A-12 and A-13, **Appendix A**). Meco then knocked down the impacted sections of concrete wall and removed any salvageable metal. Impacted concrete that was removed from the structure was placed onto plastic near B-Bank for further processing, and the pile was covered with plastic.

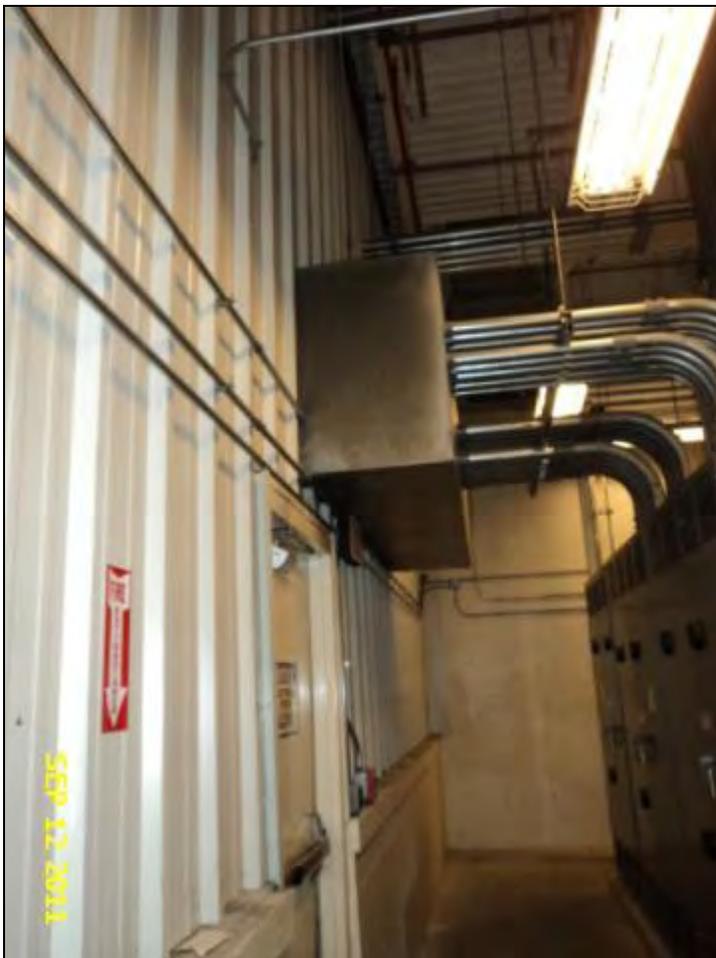
A-4: Pre-Demo view inside B-Bank, looking south at east wall.

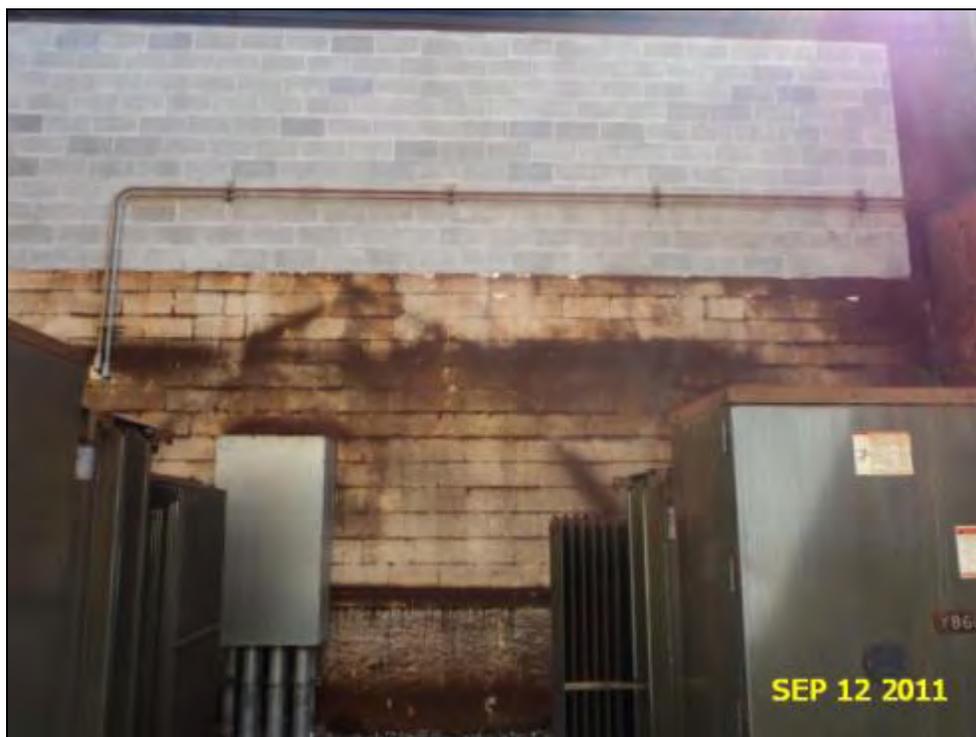
A-8: Pre-Demo view inside C-Bank, looking east at east wall.

Prior to demolition activities, SAIC (the EI) marked the impacted concrete areas with red paint to allow for segregation of the impacted versus un-impacted demolition debris by the demolition contractor (see photos A-16 and A-17, **Appendix A**). Beginning in early January 2012, the C-Bank structure was demolished in stages to allow removal of salvageable electrical components, followed by demolition of the walls, down to the impacted zone along the lower eastern wall. The un-impacted debris was segregated and removed first, leaving only the

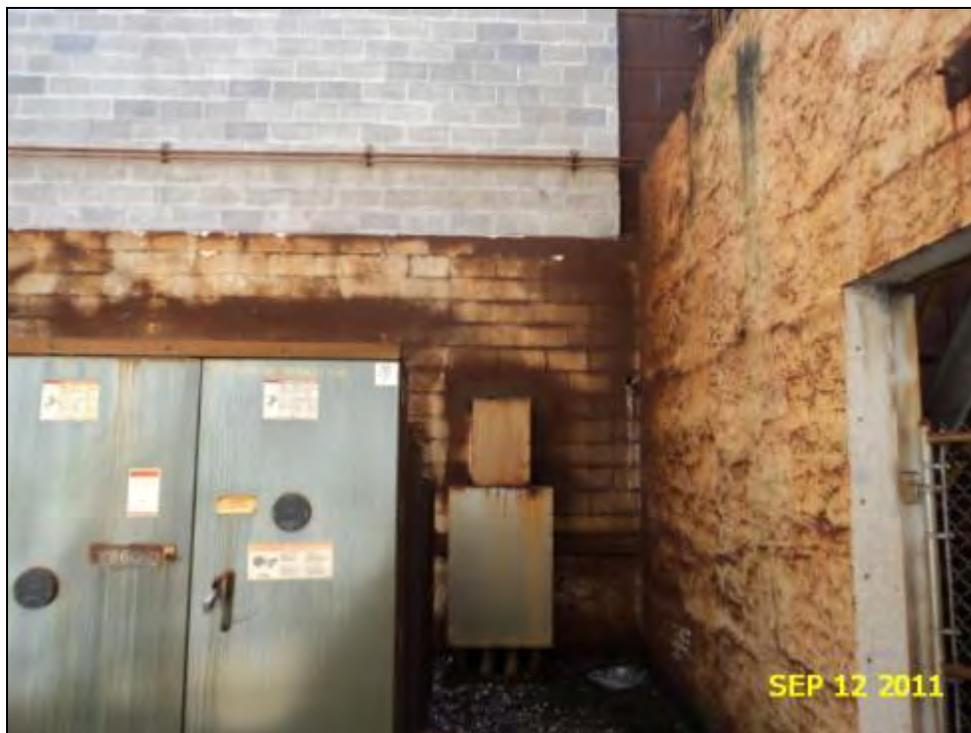
A-9: Pre-Demo view inside C-Bank, looking east at east wall.

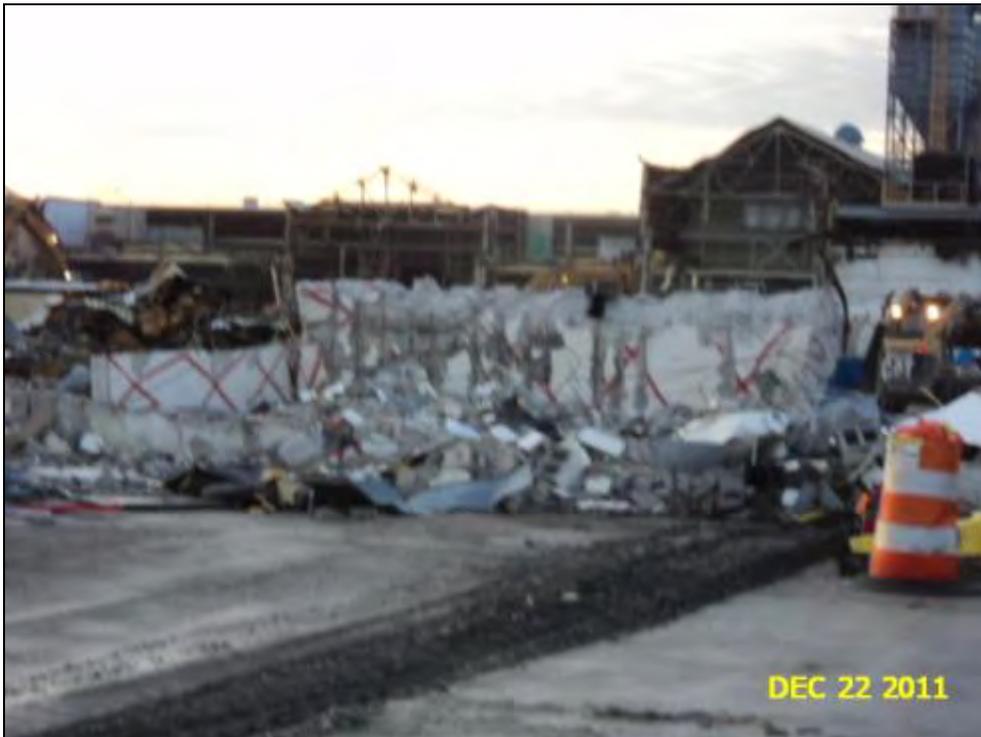
A-12: Demolition view - Looking southeast at B-Bank during Building 2 demolition. The PCB-impacted concrete (marked with the red X's) was segregated from other demolition debris.

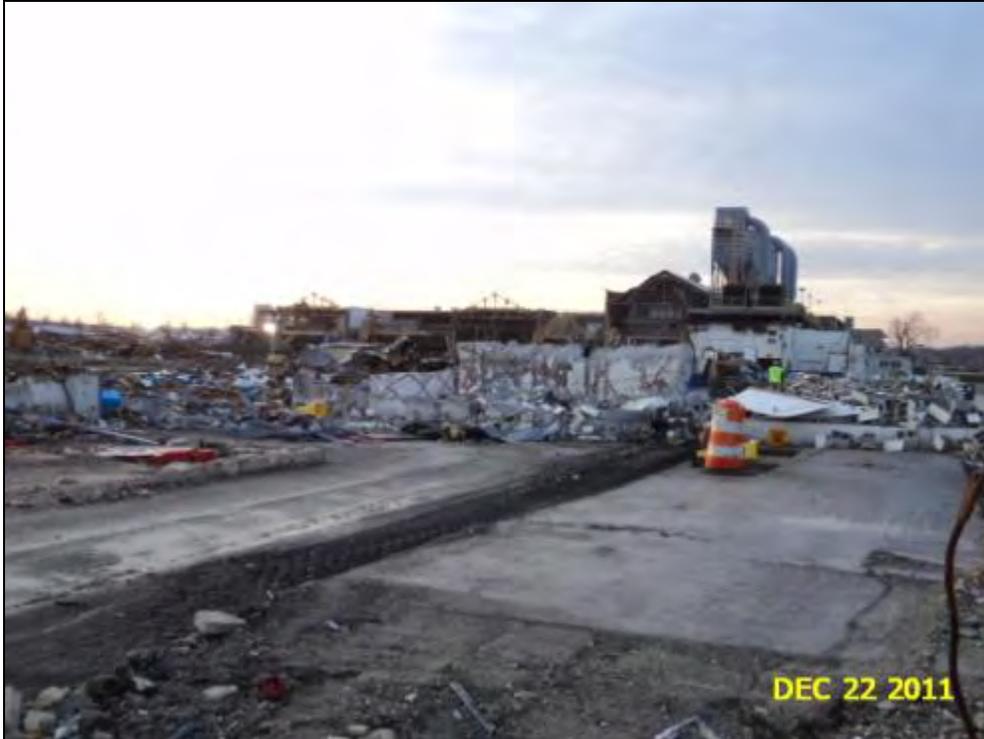
A-13: Demolition view - Looking southeast at B-Bank during Building 2 demolition. The PCB-impacted concrete (marked with the red X's) was segregated from other demolition debris.

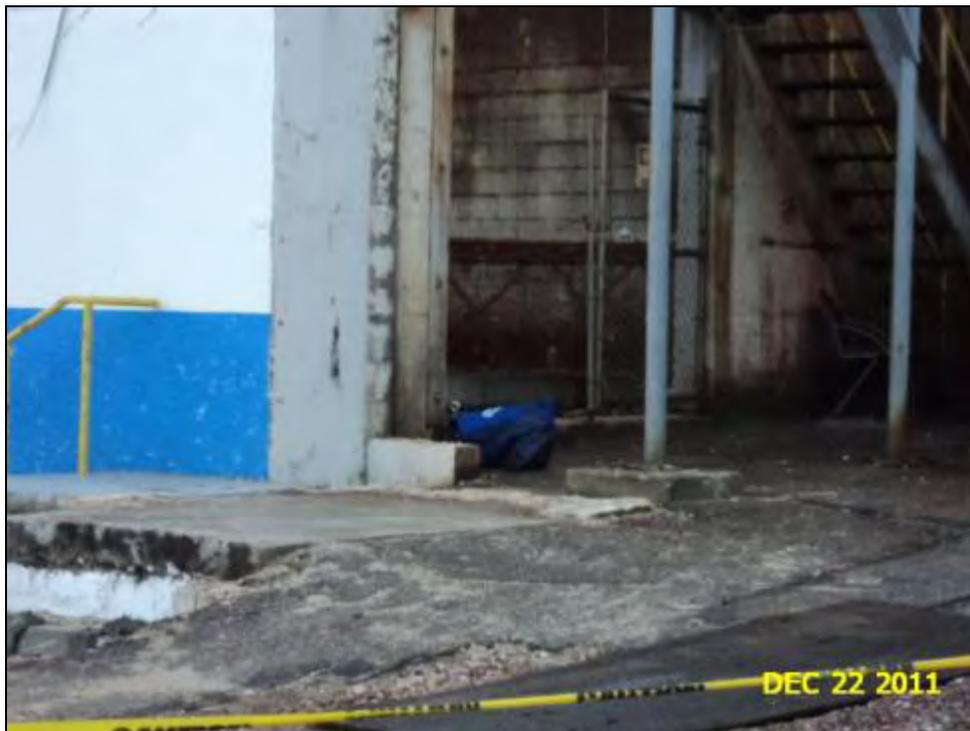
A-16: Looking northeast into the south entrance of C-Bank. PCB-impacted concrete (marked with the red X's) was separated from other demolition debris for proper disposal.

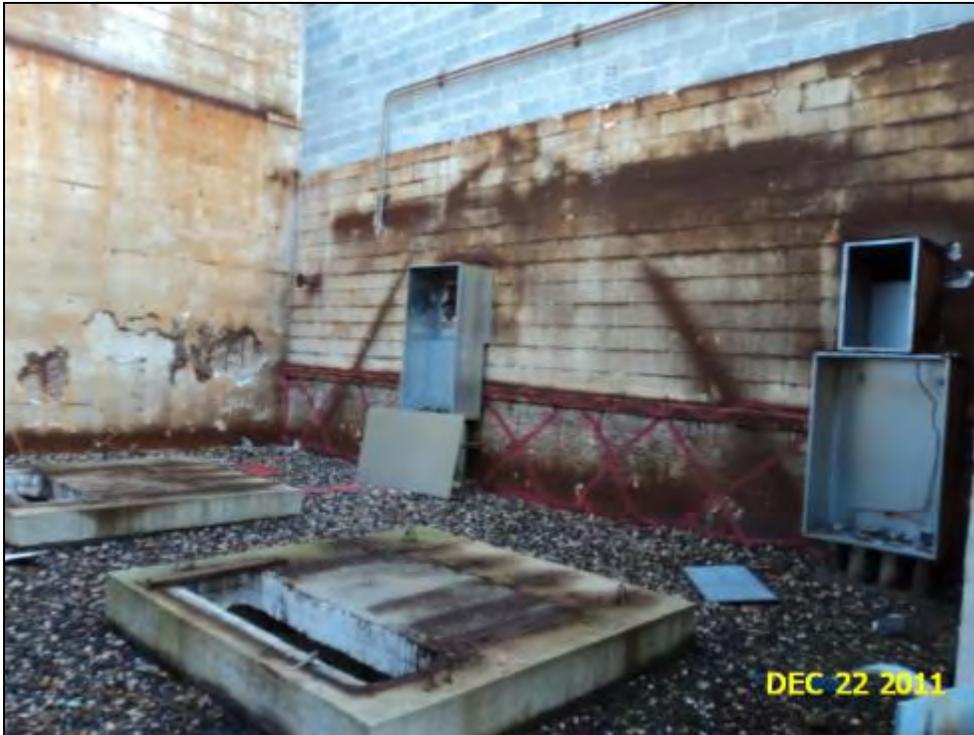
A-17: Looking northeast at the east wall inside C-Bank. The PCB-impacted concrete (marked with red X's) was segregated for proper disposal.

PCB-impacted concrete. Meco then knocked down the impacted section of concrete wall and removed any salvageable metal.

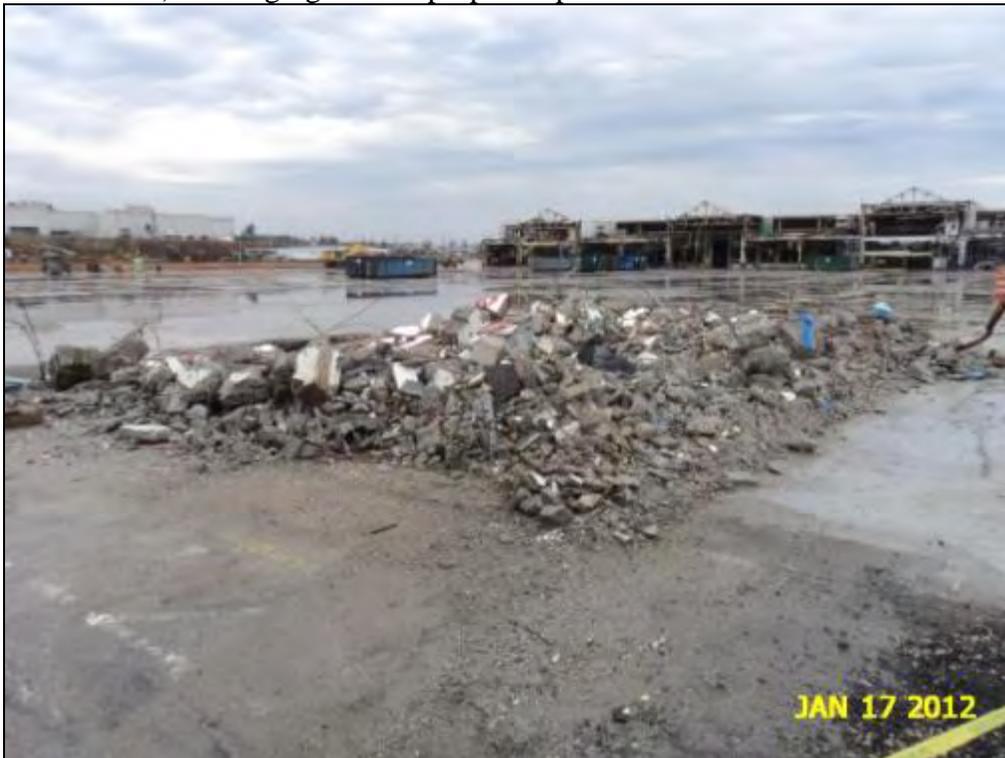
A-18: Post-Demo view - Looking southeast at impacted concrete pile from B-Bank demolition. Note red paint marks on the debris pile.

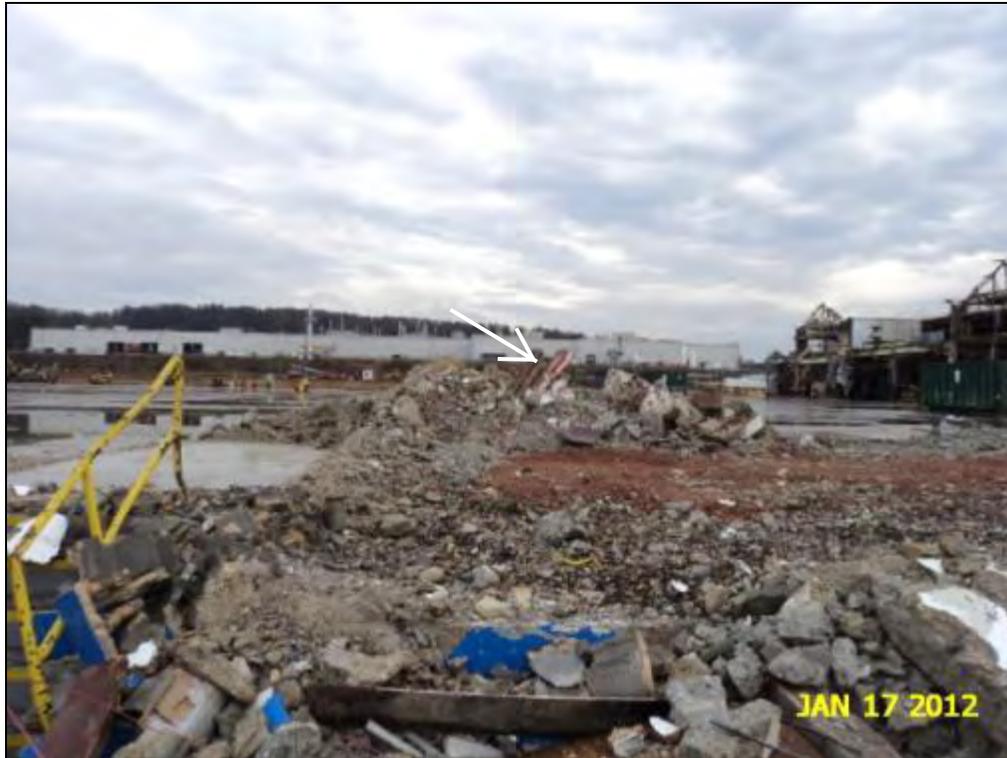
A-19: Post-Demo view - Looking east at concrete debris from C-Bank demolition. Note red paint marks (indicated by white arrow) on the debris.

Impacted concrete that was removed from the structure was placed onto plastic, along with impacted concrete from B-Bank, near the former B-Bank area for further processing. Special equipment was used to crush the concrete into sizes of less than six inches (see photo A-20, **Appendix A**). After processing, the crushing and handling equipment was decontaminated, and the pile was re-covered to await shipment and off-site disposal. Following demolition of the aboveground structure at C-Bank, additional gravel was placed, leveled, and compacted over the existing gravel and former transformer pad areas within the C-Bank footprint.

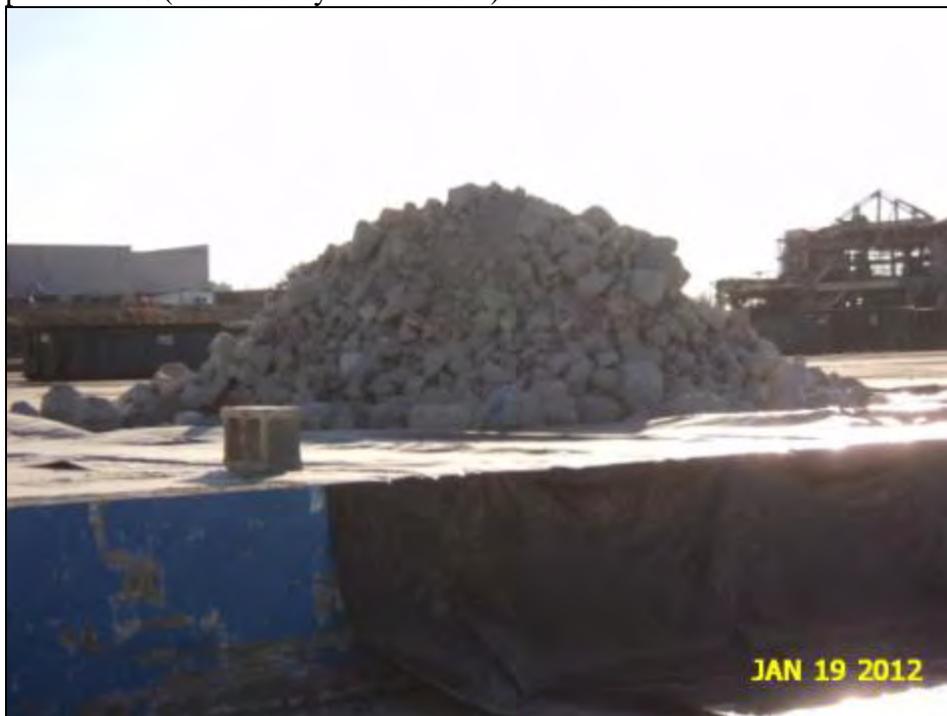
A-20: Post-Demo view - Looking at crushed impacted concrete pile from B-Bank and C-Bank areas prior to loading and off-site shipment. The crushed concrete pile is on plastic.

Later, similar material from C-Bank was added to the impacted stockpile, and special equipment was used to crush the concrete into sizes of less than six inches (see photo A-20, **Appendix A**). Following processing, the crushing and handling equipment was decontaminated, and the pile was covered to await shipment and off-site disposal. The concrete floor of B-Bank was not disturbed during the demolition activities. A clean continuous concrete slab was left intact across this area following demolition.

Lined dump trailers were delivered from EQ on February 1 and 2, 2012, for loading and shipment of the impacted debris to the CWM Model City Landfill. Approximately 38 tons of TSCA hazardous concrete were loaded from the former B- and C-Bank walls and shipped off-site (2 loads) to Model City Landfill for disposal. Copies of the waste manifests associated with the two waste shipments are provided in **Appendix B**.
