INTERIM REMOVAL AND CLOSURE REPORT BUILDING 4, BUILDING 41, BUILDING 51 AND HISTORIC WASTEWATER CONVEYANCE AREAS FORMER YORK NAVAL ORDNANCE PLANT

SAIC Project 2603100069

Harley-Davidson Motor Company Operations, Inc. York, PA

June 2012

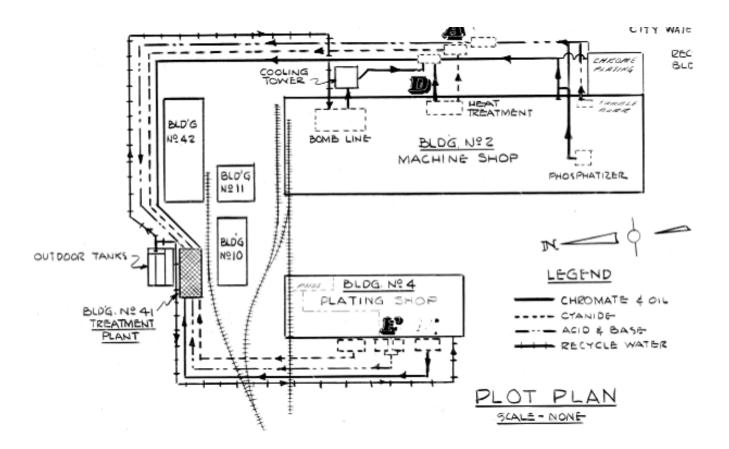
The approximate locations of the historic conveyance lines from Building 2 and Building 4 to the IWTP (Building 41) are shown on **Figure 2**. A historical sketch of the conveyance lines, prepared by AMF in the late 1960's or early 1970's, is provided below:

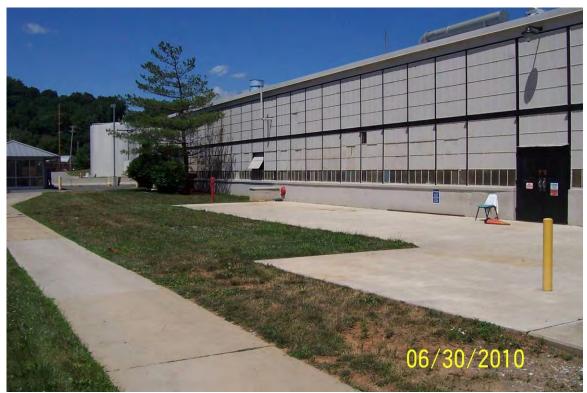
A1: View looking north along exterior NW corner of Bldg 4. Former AMF degreaser area is located immediately inside double doors. Gate 4 and north fire tank visible at upper left

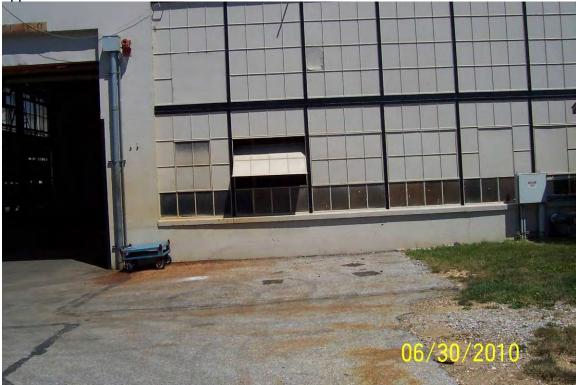
A2: View from Gate 4 of NW corner of Bldg 4, looking east. Scar from former solvent containment for N degreaser was located immediately along bldg windows.

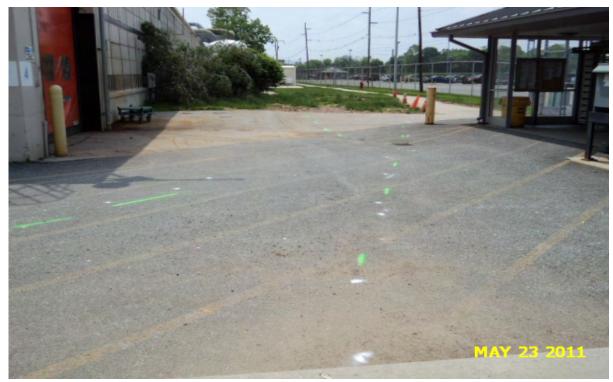
A3: View looking south of NW exterior corner of Building 4 and Gate 4 (right). Note green markings on pavement from historic wastewater piping locating.

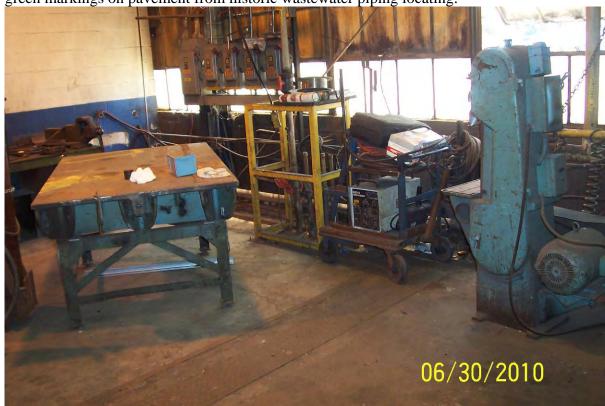
A4: View inside NW corner of Bldg 4 at location of former northern degreaser area.

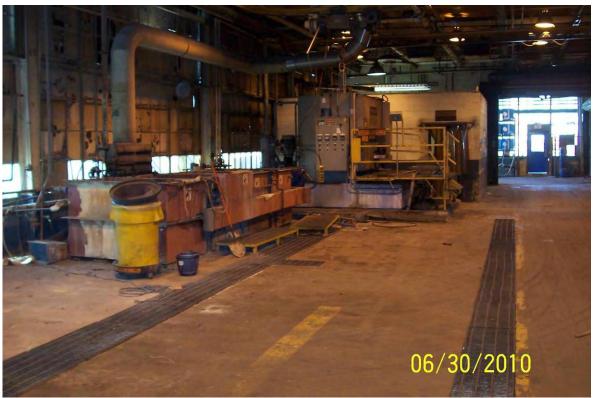
A5: View looking north inside NW corner of Bldg 4 - block wall area surrounds former northern degreaser area.

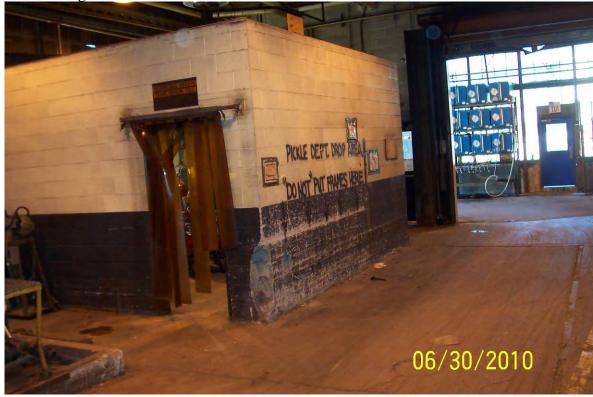
A6: View looking north inside NW corner of Bldg 4 - block wall area surrounds former northern degreaser area. Note faint floor marks of former degreaser vault.

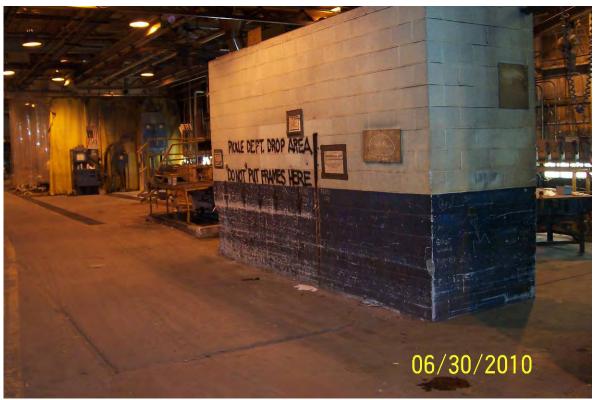
A7: View looking south west inside NW corner of Bldg 4 - Note block wall area surrounding former northern degreaser area.

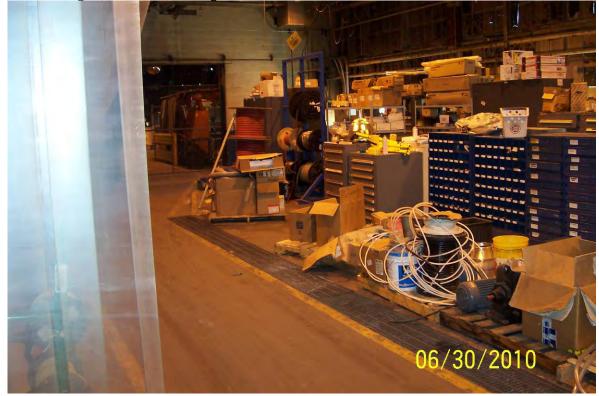
A8: View of former AMF degreaser area in N end of Bldg 4. Cyanide waste found beneath floor (under maintenance storage cabinets).

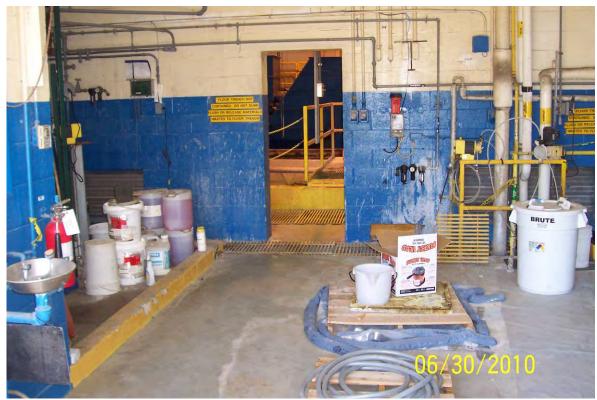
A9: View looking north into WWTP (Bldg 41), former CN neutralization pit area; floor trenches; and EQ tank area (through door).

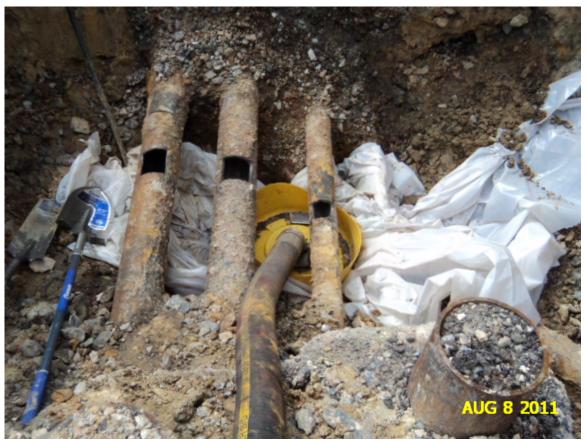
A10: Former wastewater conveyance pipe cleaning photos. Note condition of pipe interior, (photo A11, below).

Due to the length of the pipelines and limited reach with cleaning tools, several excavations were planned at strategic locations to access, expose, and complete the pipeline cleaning. The pipeline cleaning and abandonment activities included cutting/draining all pipes from one end, flushing all pipes with water, containerizing all fluids, and permanently capping abandoned pipes with concrete plugs. Following cleaning, video documentation of the pipeline condition was also completed.

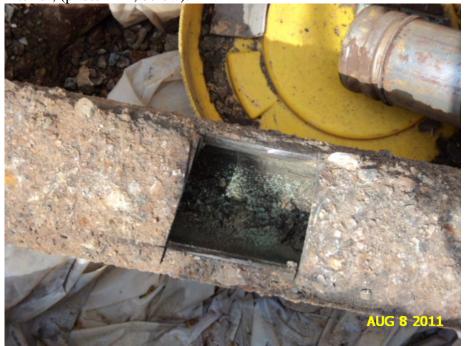
A11: Close-up of former 4-inch diameter Chromate wastewater conveyance pipe – cut open for inspection/cleaning.

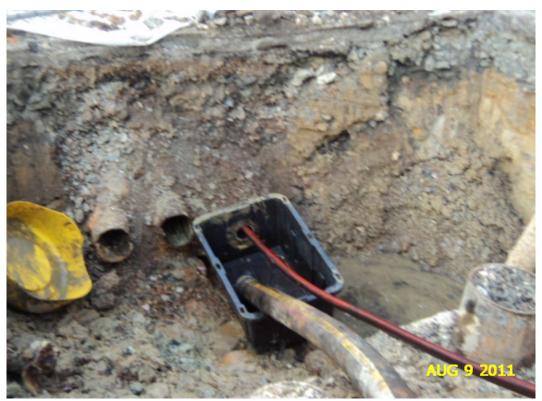
A12: Photo of underground pipe cleaning technique – high pressure wash while vacuum removal and onsite containment.

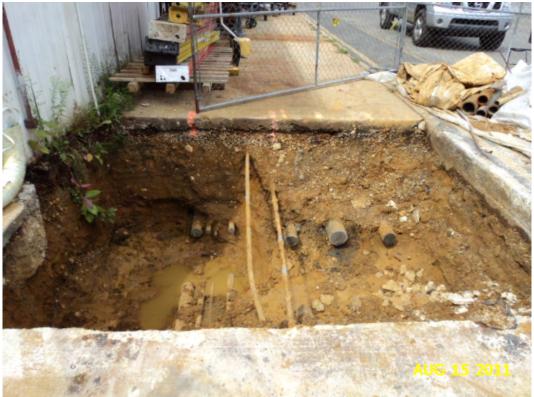
A13: Photo of one pipe cleaning excavation following cleaning and capping of pipe [prior to backfill].

The A/A and chromate conveyance line cleaning water was containerized in a large frac tank, separately from possible cyanide-bearing cleaning water, which was transferred to a 5,000-gallon poly tank. All cleaning water was characterized and properly disposed of off-site. After the lines were cleaned, they were televised with a video camera that was fed through the pipes to verify their condition. A copy of the contractor's video report is provided in **Appendix B**. Additional cleaning was conducted, if needed. Following verification, the ends of the pipes in the excavations were capped with concrete and the excavations were backfilled (see photo A-13, **Appendix A**).

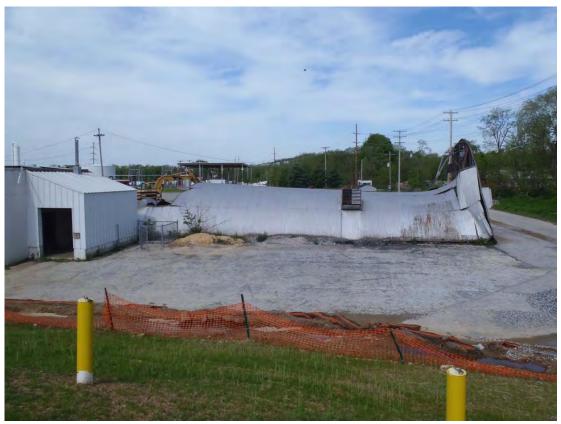
A14: Photo of Bldg 51 (view looking west) during initial demolition. (May 2011).

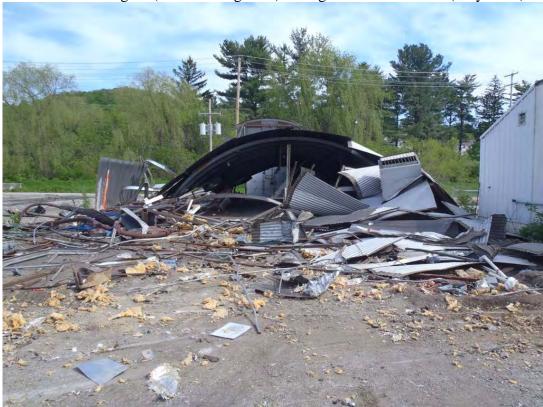
A15: View looking north of demolition of former Bldg 51 (May 2011)

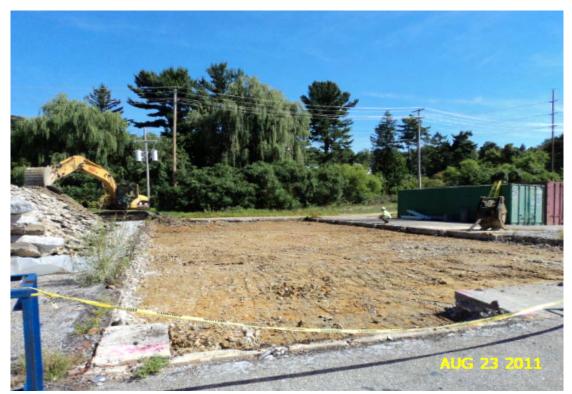
A16: View looking north at Bldg 51 following demolition and removal of former hazardous waste storage pad and underlying gravel, and prior to confirmation sampling.

Interim remedial actions began at the former Building 51 hazardous waste storage pad in August 2011. Approximately one foot of bituminous concrete, concrete pads, and underlying gravel was removed and staged on and covered with plastic (see photos A-16, **Appendix A**). The bituminous concrete, gravel, soil, and concrete were sampled for off-site disposal.

The soil below the bituminous concrete and concrete pads was scanned with a PID and visually inspected. No additional soil was removed since there were no elevated PID readings above background, and no staining or unusual odors were observed.

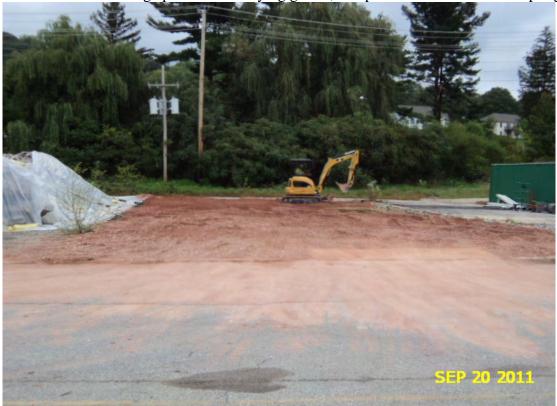
A17: View looking north at backfilled excavation of former Bldg 51 area.

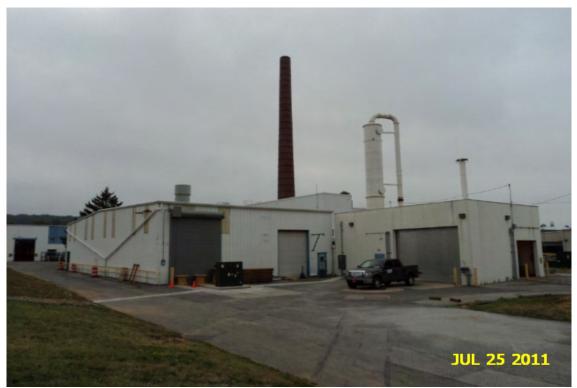
A18: View looking southeast at Bldg 41 (wastewater treatment building) prior to demolition. Note GW treatment facility (on right) and Bldg 10 smoke stack in background.

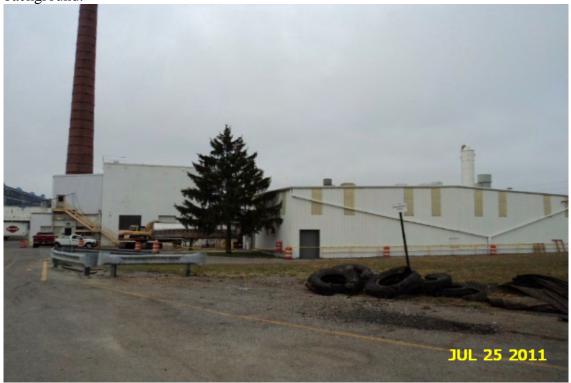
A19: View looking south at north side of Building 41 (wastewater treatment building) prior to demolition. Note Building 10 and smoke stack on left.

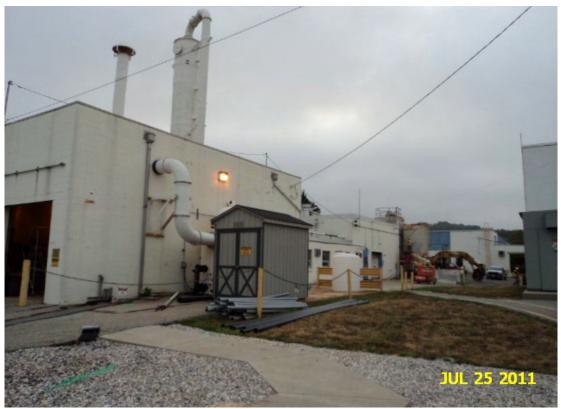
A20: View looking northeast at the Groundwater Treatment facility and Building 41 (wastewater treatment building, on right) prior to demolition.

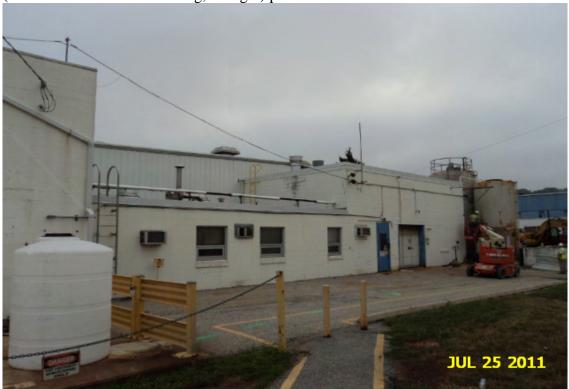
A21: View looking north at south side of Building 41 (wastewater treatment building) prior to demolition.

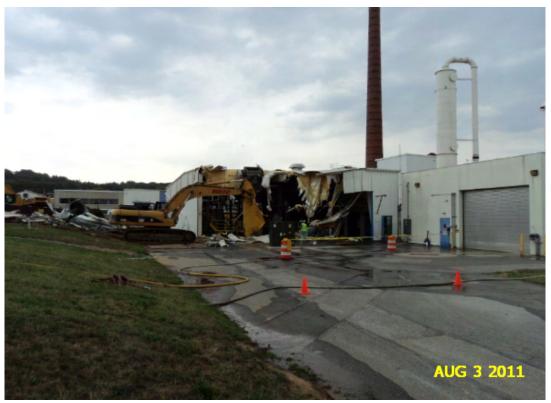
A22: View looking southeast at Bldg 41 (wastewater treatment building) during demolition. Note groundwater treatment facility (on right) and Bldg 10 smoke stack in background.

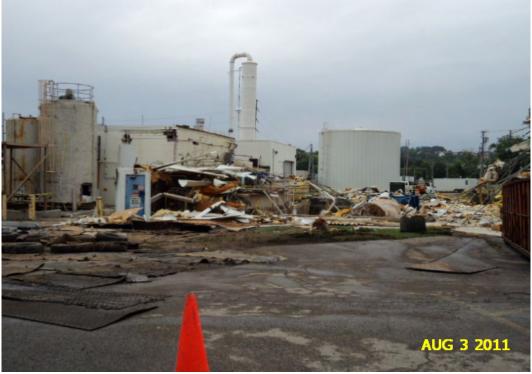
A23: View looking west at Bldg 41 (wastewater treatment building) during demolition. Note groundwater treatment facility and fire protection tank (in background).

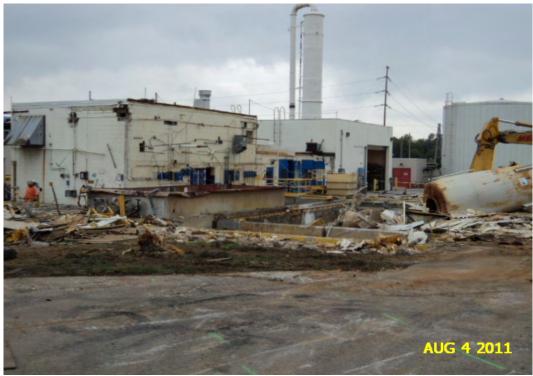
A24: View looking west at Building 41 (wastewater treatment building) during demolition. Note EQ tank and green marks on asphalt (fmr underground ww piping).

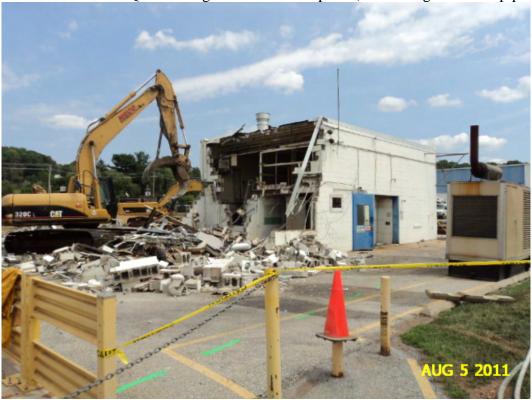
A25: View looking northeast at Bldg 41 during demo. Note green markings on asphalt showing the location of former underground cyanide wastewater piping (from Bldg 4).

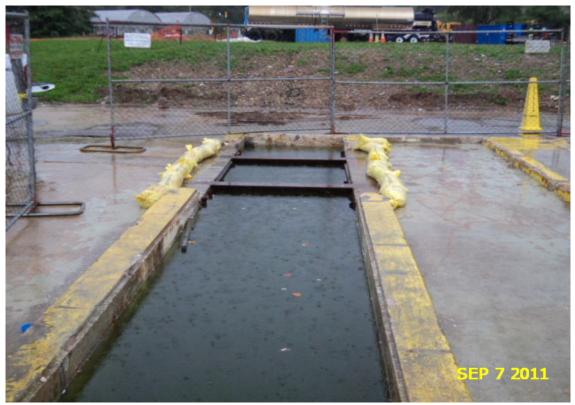
A26: View looking north of former sludge pit filling with rainwater following demolition of building 41 above-ground structure. Note sand bags lined on ground in attempts to slow run-in.

Preliminary activities were also needed prior to initiating interim remediation activities at the IWTP. After the IWTP was demolished, heavy rains in early September 2011 caused the former sludge pit to become filled with run-in water (see photo A-26, **Appendix A**). Thus, before interim remediation activities could start, approximately 14,000 gallons of wastewater were removed and properly disposed of off-site.

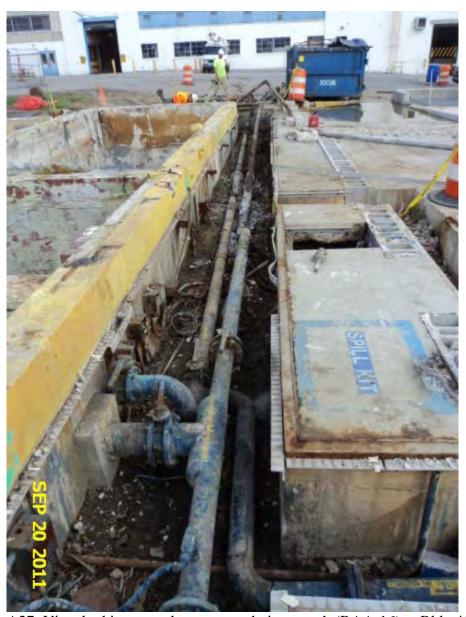
A27: View looking east along exposed pipe trench (RAA-16) at Bldg 41 (Bldg 42 in background). Photo is after building demolition and prior to pipe removal and remediation.

Following the removal of former piping in the subgrade trenches (RAA-15 and RAA-16), the underlying solids, sludge, and gravel from the former interior and exterior trenches were removed and placed into containers for off-site disposal. With the exception of the west end of the interior subgrade pipe trench (RAA-15), there was no concrete or containment found beneath the gravel layer in any of the pipe trenches. The underlying soil material was then scanned with a PID, visually inspected, and excavated where staining, odors, or elevated PID readings were observed (there was no previous sampling beneath these trenches).

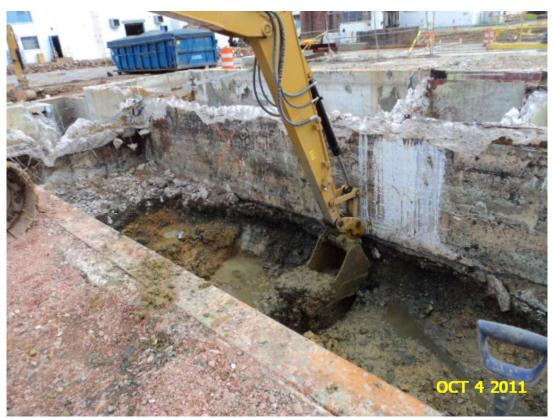
A28: Photo – view looking southeast of soil removal beneath SWMU 37 (fmr South Settling Basin) at Bldg 41

The concrete bottom of the former subgrade south settling basin (SWMU 37) was removed and placed into containers for off-site disposal. The underlying soil material was then excavated within areas where previously collected samples had concentrations greater than the MSCs and where staining or odors was observed. Approximately three to four feet of wet gravel and soil material were removed beneath the center and eastern portions of the basin and placed in containers for off-site disposal. The soil encountered at the depth of excavation also exhibited elevated PID readings. Excavation was halted after significant groundwater was encountered. Attempts were made to remove the infiltrating water and continue excavating, but the water could not be removed fast enough.

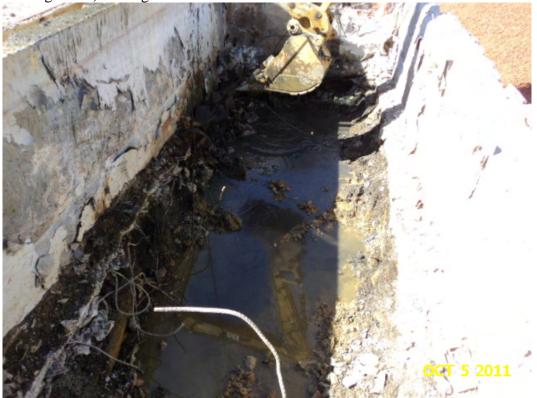
A29: Photo of excavation beneath SWMU 31 (fmr EQ tank/pit) – looking west.

A layer of black sandy material (between the steel tank insert and bottom of the former basin) and the concrete bottom of the former subgrade equalization basin (SWMU 31) was removed and placed into containers for off-site disposal. The underlying soil and sand material was then scanned with a PID, visually inspected, and excavated where staining, odors, or elevated PID readings were observed (there was no previous sampling beneath this unit). Approximately three to four feet of wet gravel and soil material were removed beneath the basin and placed in containers for off-site disposal. The soil encountered at the depth of excavation also exhibited elevated PID readings. Excavation was halted when groundwater was encountered, and confirmatory samples were collected (11 to 12 feet bgs) with the aid of the excavator (see photo A-29, **Appendix A**).

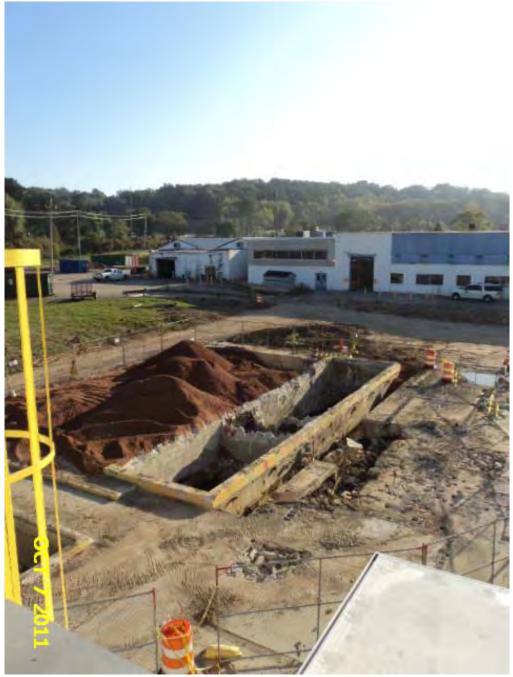
A30: View looking northeast of partial remediation and backfill of the former wastewater treatment facility at Building 41 (Building 42/57 is in the background).

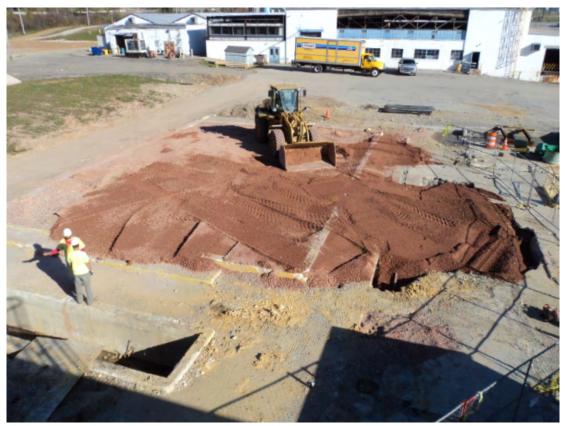
A31: View looking northeast at the former wastewater treatment facility at Building 41 – Post-remediation backfilling – photo Nov. 9, 2011

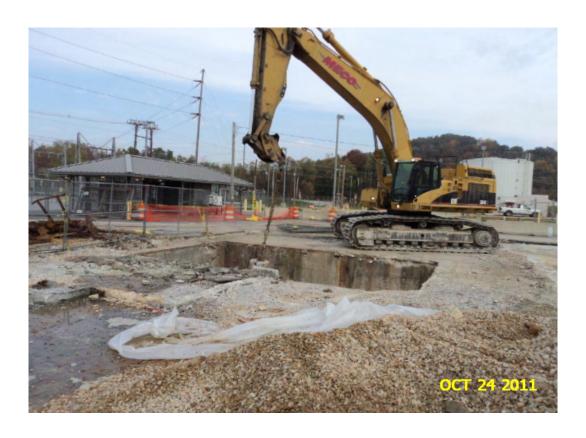
A32: View (looking north) of former below grade degreaser vault at the northwest corner of former Building 4. Note Gate 4 and north fire protection pump house in background.

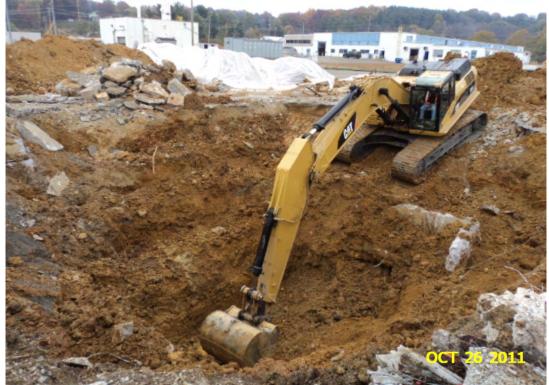
A33: View (looking northeast) of soil removal surrounding the former below grade degreaser vault at the north west corner of former Bldg 4. Note remnant of former southeast corner base of vault below trackhoe. Total depth at bottom is approx. 23' bgs.

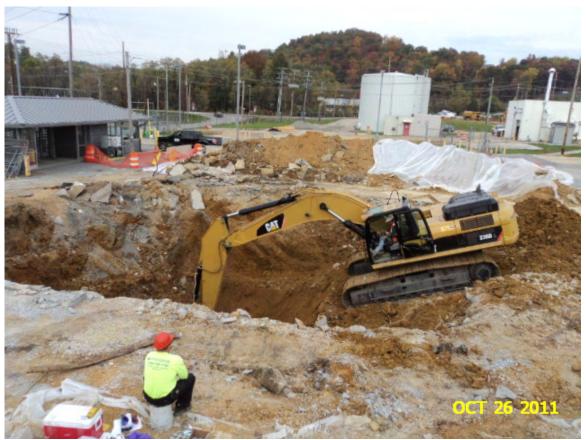
A34: View (looking north) of soil removal surrounding the former below grade degreaser vault at the north west corner of former Building 4. Note Gate 4 and north fire protection pump house in background.

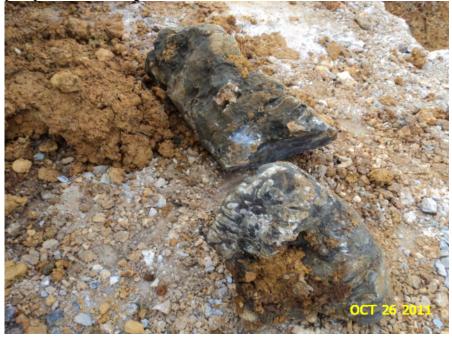
A35: View of two pieces of weathered limestone rock removed from the bottom of the vapor degreaser excavation at approximately 23' bgs.

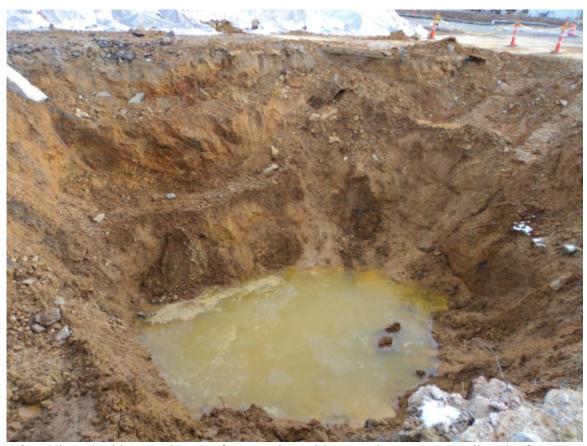
A36: View (looking northeast) of excavation with groundwater surrounding the former below grade degreaser vault at the north west corner of former Building 4.

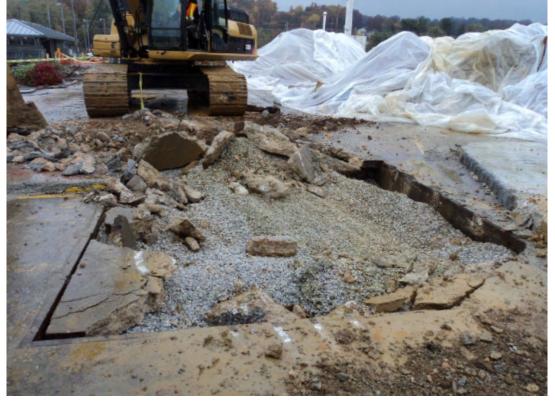
A37: View of excavation of former AMF degreaser vault (looking north).

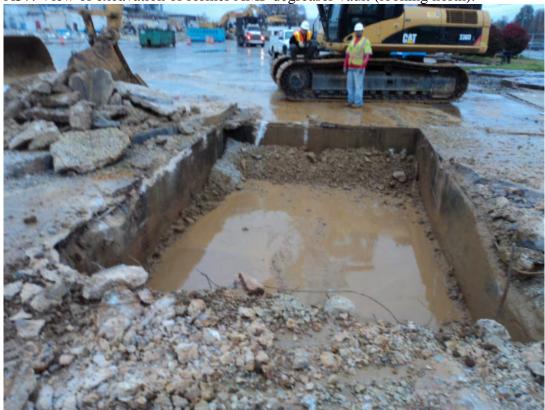
A38: View of excavation of former AMF degreaser vault (looking south). Dimensions are approximately 12' (E-W) by 20' (N-S), and 3' deep.

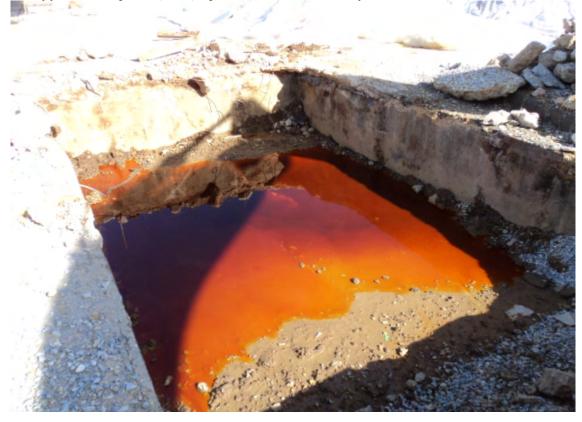
A39: View of excavation of former AMF degreaser vault (looking north). Note change

in color of liquid.

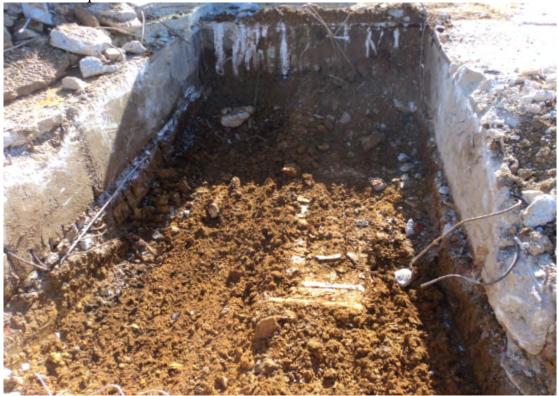
A40: View of excavation of soil beneath former AMF degreaser vault (looking south).

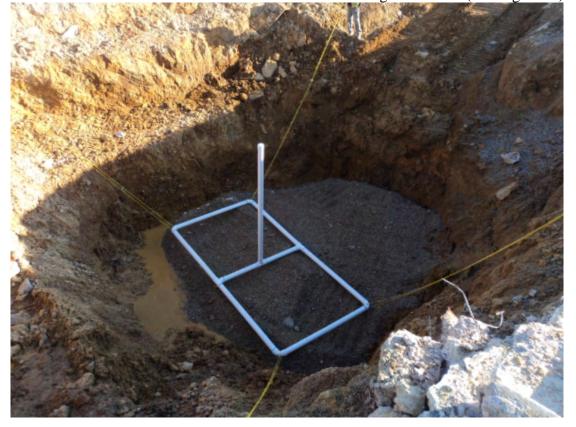
A41: View (looking northeast) of infiltration gallery installation in excavation at the northwest corner of former Building 4. [Nov. 9, 2011] Note gravel layer (approx 2' thick) placed beneath gallery.

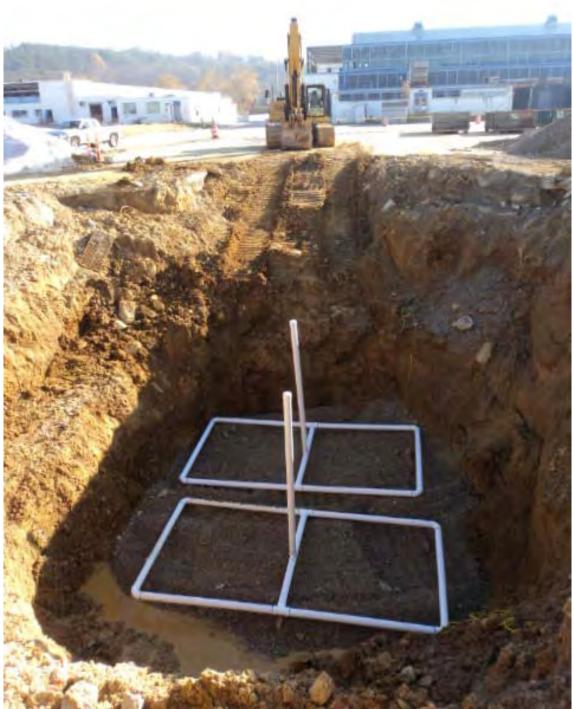
A42: View (looking east) of infiltration gallery installation in excavation at the northwest corner of former Building 4. [Nov. 9, 2011]

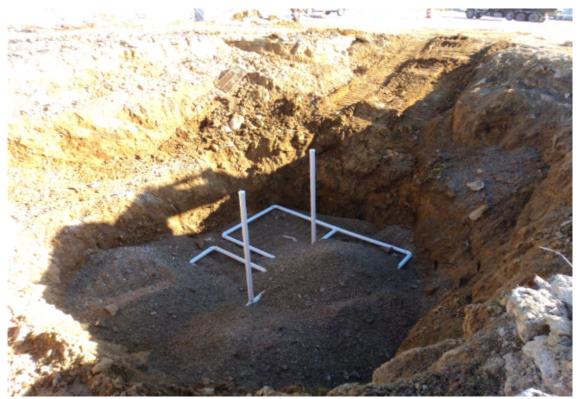
A43: View (looking northeast) of infiltration gallery installation in excavation at the northwest corner of former Building 4. [Nov. 9, 2011]

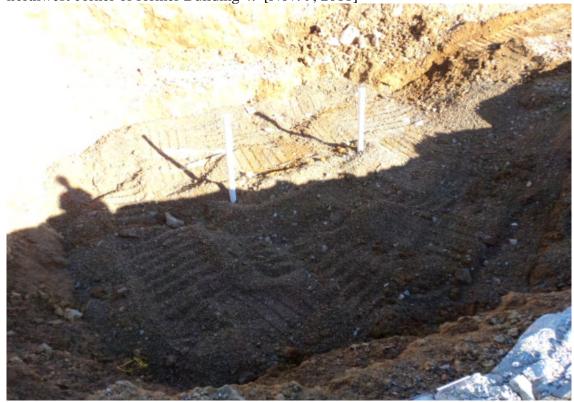
A44: View (looking northeast) of infiltration gallery installation in excavation at the northwest corner of former Bldg 4. [Nov. 9, 2011]. Stone backfilled to approx. 16' bgs.

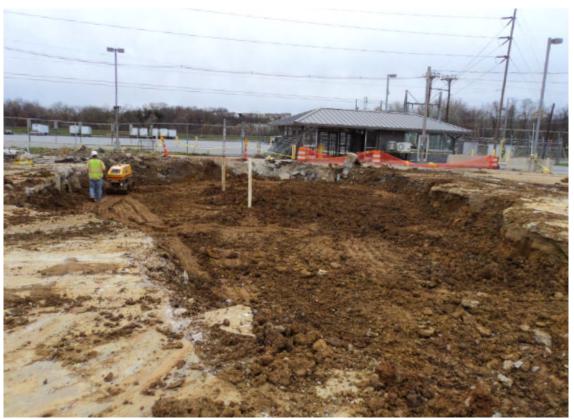
A45: View (looking west) of partially backfilled excavation and infiltration gallery (PVC uprights) at the northwest corner of former Building 4.

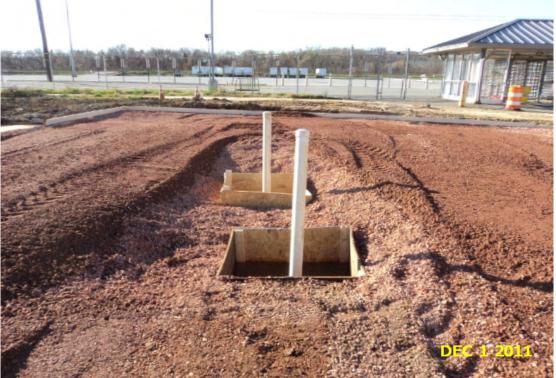
A46: View (looking west) of surface completions preparations for infiltration gallery access in excavation at the northwest corner of former Building 4.

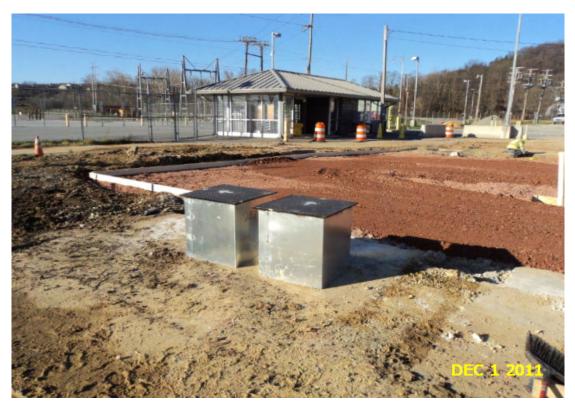
A47: View (looking northwest) of infiltration gallery surface completion access vaults prior to installation at the northwest corner of former Building 4.

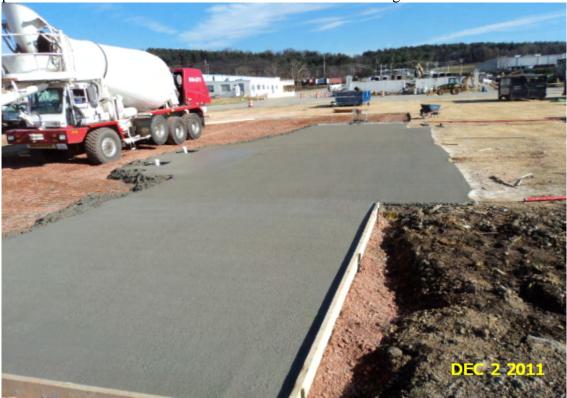
A48: View (looking east) of concrete pad installation over excavation and infiltration gallery at the northwest corner of former Building 4.

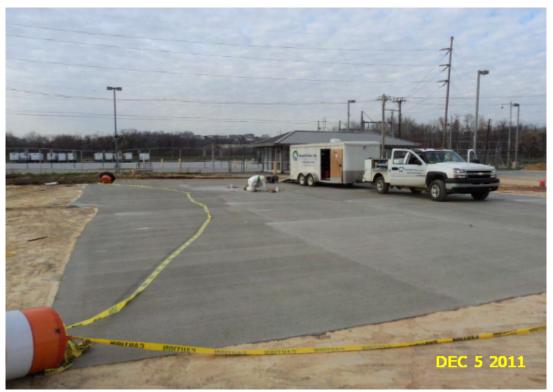
A49: View (looking west) of concrete pad completion over excavation and infiltration gallery at the northwest corner of former Building 4.

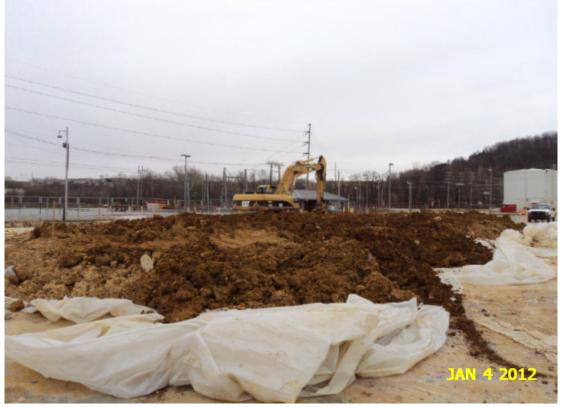
A50: View looking northwest at soil pile characterization sampling conducted with trackhoe.

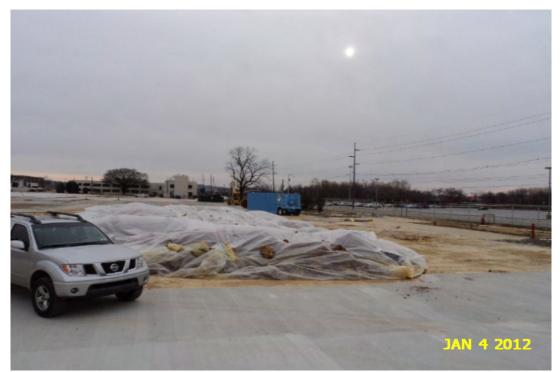
A51: View looking south from north end of former Bldg 4 – of stockpiled hazardous soil and blue frac tank with hazardous remediation liquid.

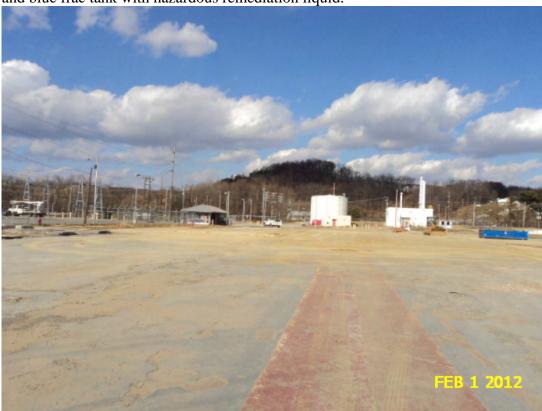
A52: View looking north from former Bldg 4 pad following removal of hazardous soil stockpile, and remediation liquids/frac tank. Note Gate 4, north fire protection tank and groundwater treatment building in background.

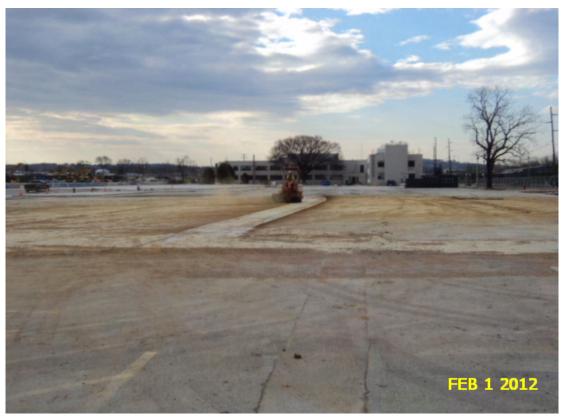
A53: View looking south from north end of former Building 4 pad area – sweep cleaning pad following removal of all wastes and soil.

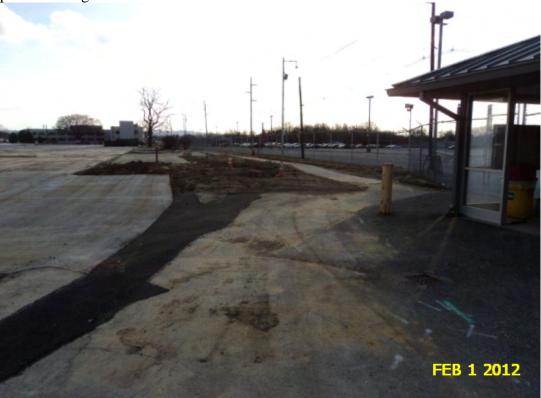
A54: View of Northwest corner of Building 4 and Gate 4 (right) looking South following completion of remediation and restoration activities.

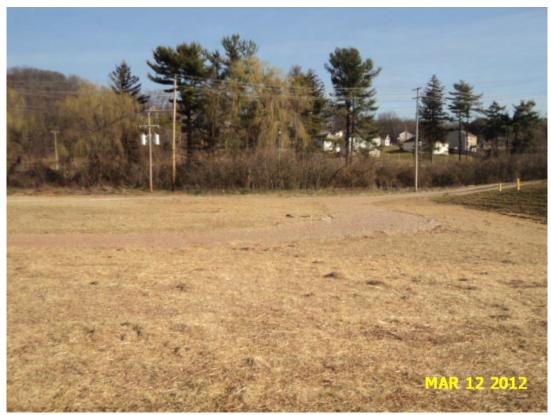
A55: View looking north across restored area of former Bldg 51.

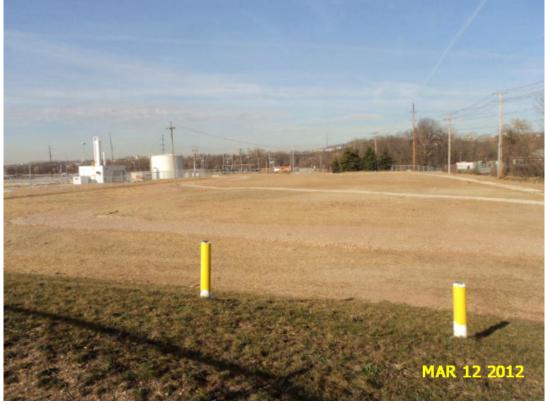
A56: View looking west across restored area of former Bldg 51 (note walking path, gravel drive and topsoil/seeded restorations).

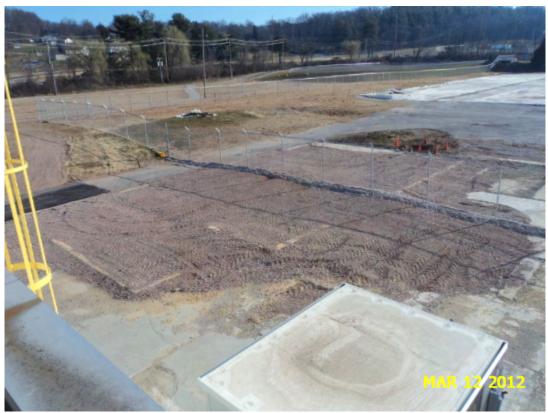
A57: View looking northeast across the former wastewater treatment facility at Building 41. Note new fenceline installed along East/West Campus boundary.

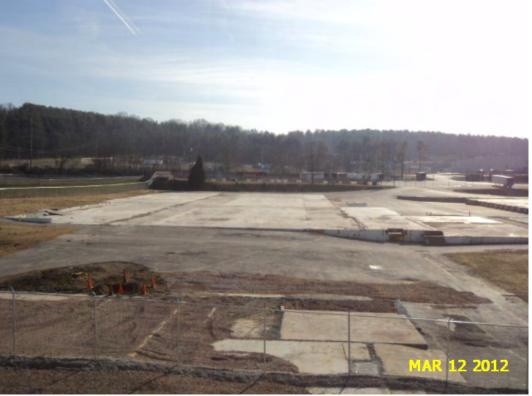
A58: View looking East across the former wastewater treatment facility at Building 41 (demolished Building 42/57 is in the background).
