GROUNDWATER SCIENCES CORPORATION

Re: fYNOP Offsite Geological Mapping Activities

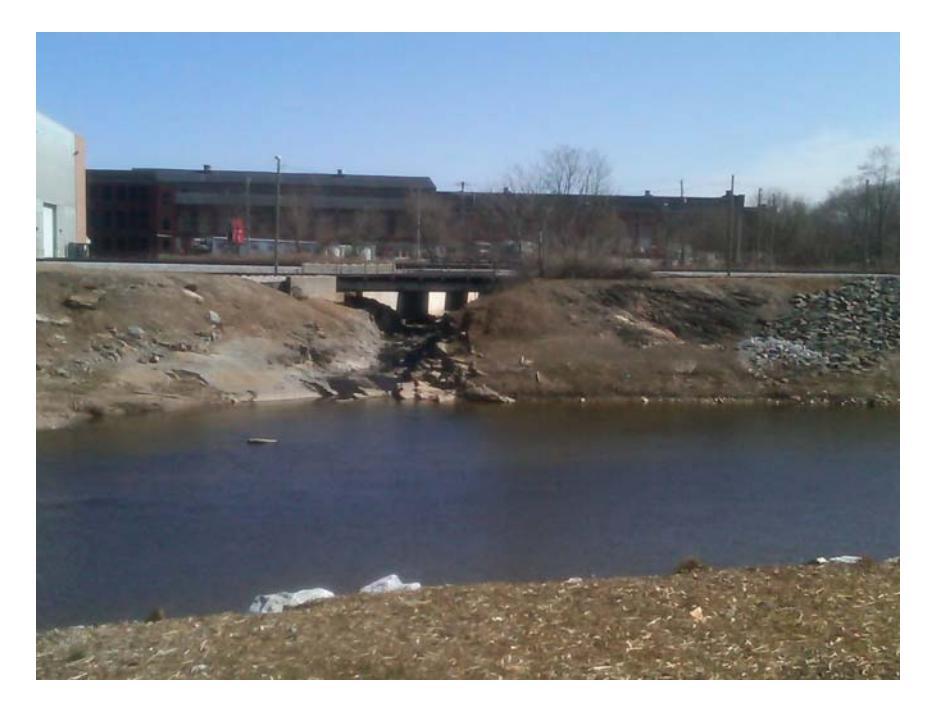
Photo 1: View east toward an outcrop along Codorus Creek showing contact of Vintage Formation with overlying Kinzer Formation. Kinzer shale is visible to the right, the transitional contact in center, and the Vintage dolostone to the left. Beds are dipping to the south (right).

good outcrop was observed and measured on the east side of Codorus Creek immediately south of an apparent plunging anticline on the Prospect Hill block (Photo1). The Kinzer shale has been mapped as subcropping as an easterly-plunging syncline that is terminated by the fault block just north of the Gnatstown thrust fault. The outcrop occurred at the mouth of a small unnamed stream and displayed the basal Kinzer shale unit and the contact between the Kinzer and the underlying Vintage Formation. This contact was observed to be a transitional contact with the siliceous knotty dolomite of the Vintage Formation and the basal shale of the Kinzer Formation. The transitional contact is characterized as earthy limestone (Photo 2) with interbeds of knotty siliceous dolostone (Photos 3 and 4) and some gray limestone and dolostone (Photo 5). This outcrop and the observed contact facilitated the redrawing of the contact between the Vintage and the Kinzer formations in this area as shown on the geologic map. The contact was drawn to honor the historical mapped carbonate pit between North George Street and Willis Run. While the bottom contact location changes significantly in this area, the shale continues to the south edge of the Prospect Hill block and maintains a continuous shale belt in the vicinity of Codorus Creek north of the Gnatstown thrust fault.

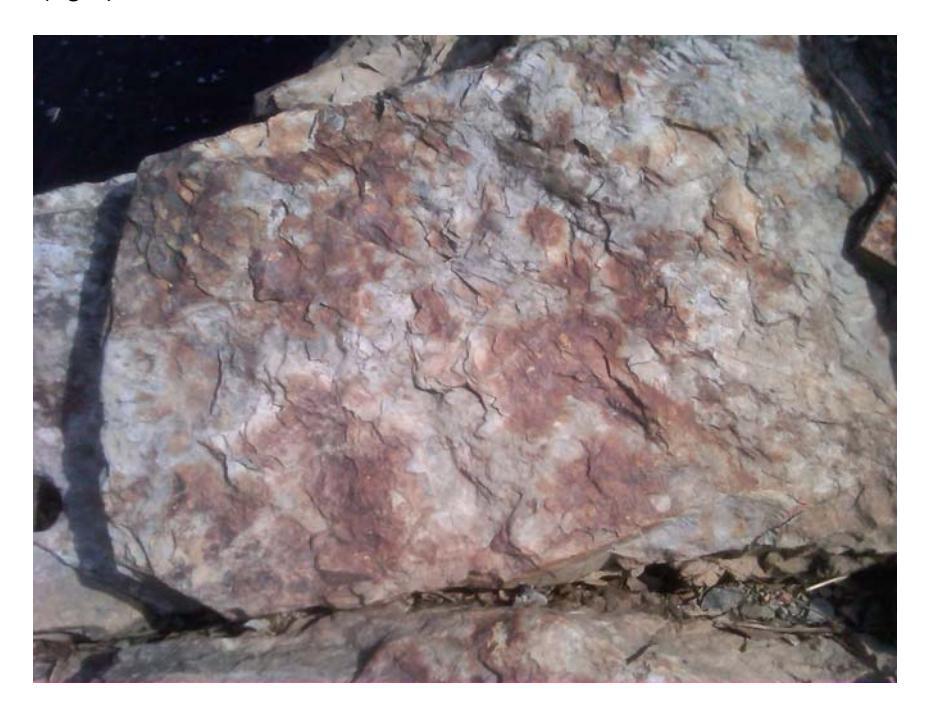
Photo 2: Overhead view of earthy limestone at the top of the Vintage Formation at transitional contact with the overlying Kinzer Formation. Iron staining on surface due to the presence of weathered pyrite. North is to the top of photo.

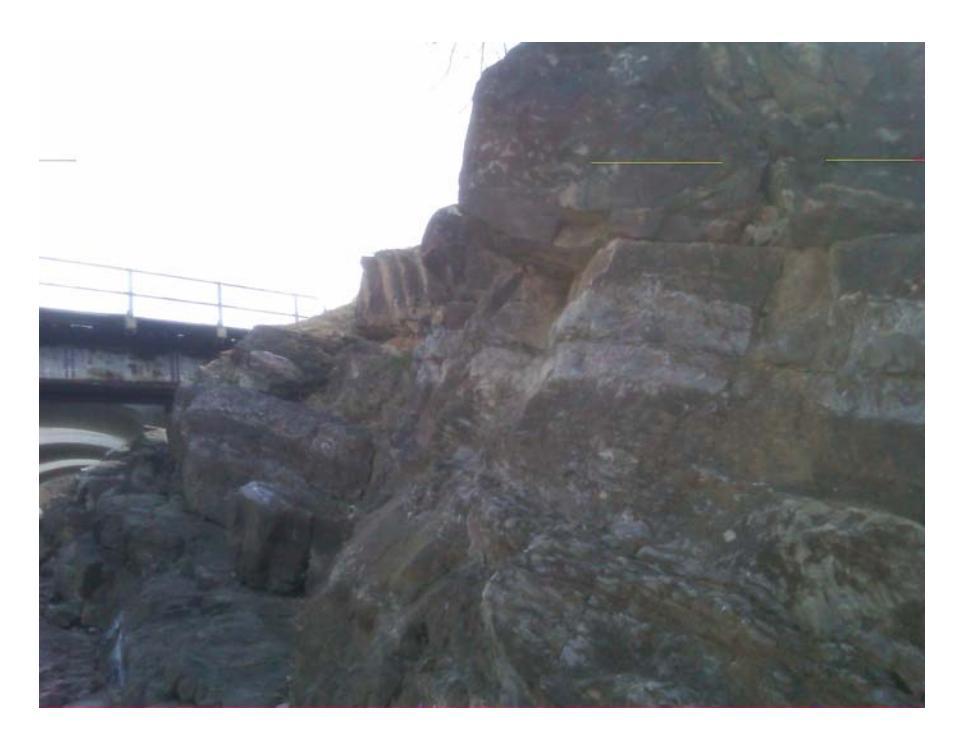
Photo 3: View east of interbedded knotty siliceous dolostone with earthy limestone at top of Vintage Formation dipping to the south (right).

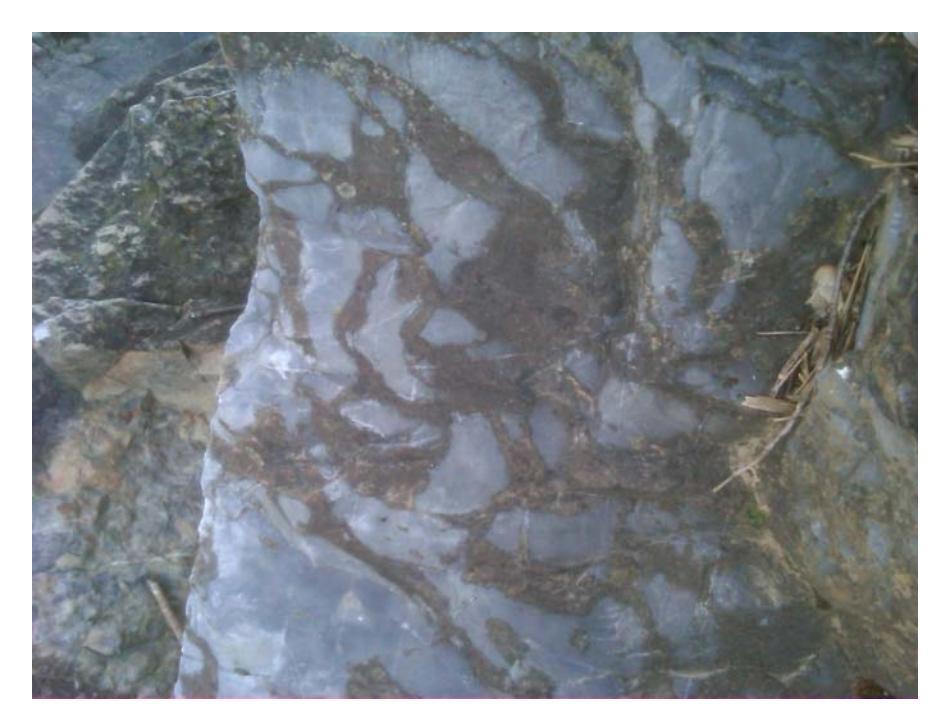
Photo 4: Eastward and downward close-up view of knotty siliceous dolostone of the Vintage Formation near contact with the Kinzer Formation from Codorus creek outcrop. Same rock type was observed along Toronita Street and North George Street at the contact with the Kinzer shale.

The observations made at the Codorus Creek outcrop were useful in interpreting the observations made along Toronita Street west of the Harley site. There, the contact between the Vintage and the Kinzer formations was moved westward to a point at Toronita Street where knotty dolostone was observed in outcrop near an earthy limestone that was within a few yards of good outcrops of Kinzer shale. The findings in this area suggested a transitional contact like that observed along Codorus Creek to the south and justified moving the contact further west. In addition, the documented average thickness of the Kinzer shale has been estimated to be about 200 feet thick by Stose and with dips in the area being about 25-30 degrees west, the thickness. As it is mapped on the project geologic map, the subcrop belt of the Kinzer supports the observations and assumptions, while honoring the topography in the area where the shale typically forms low hills and ridges like the one northeast of the I-83 interchange.

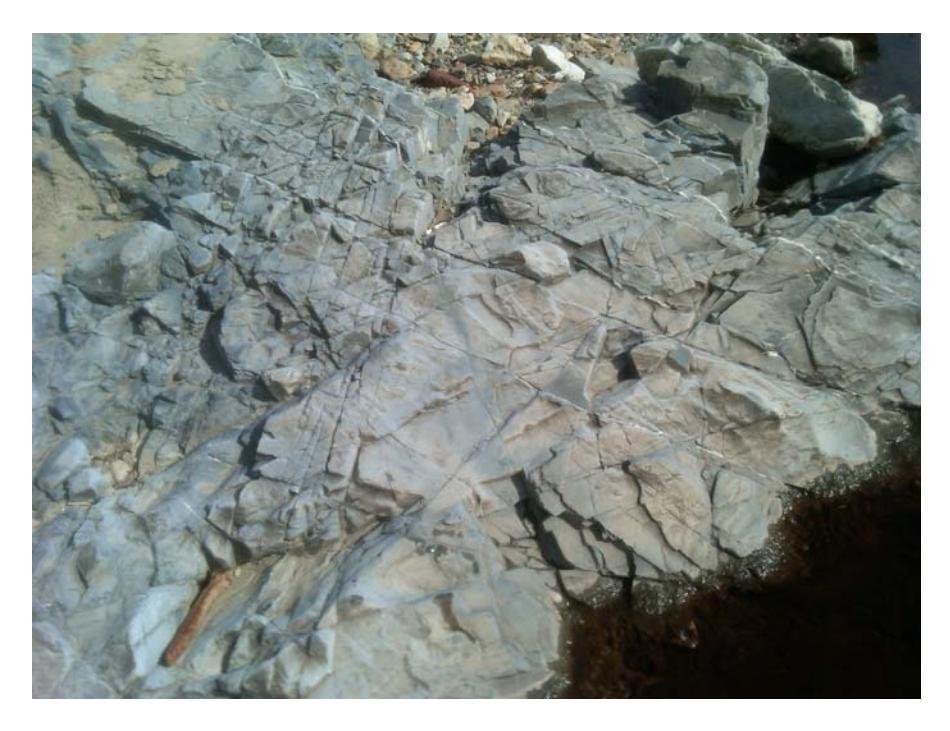
Photo 5: Eastward and downward view of gray limestone and dolostone of the Vintage Formation below the transitional beds at outcrop along Codorus Creek. Shows various joint sets and closely spaced jointing on the left. RR spike shows scale.

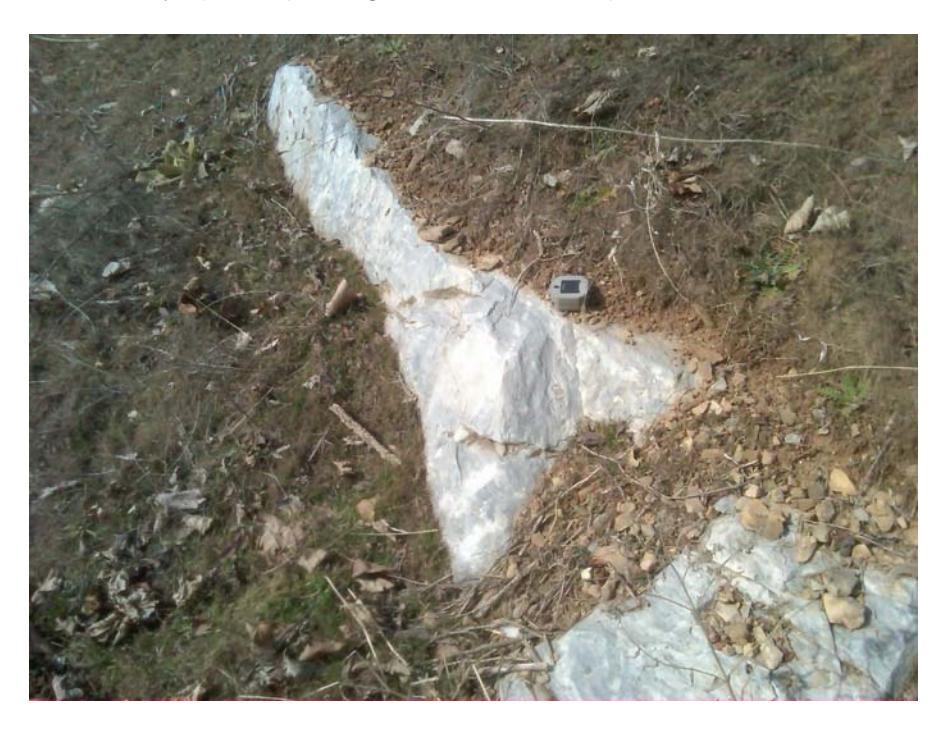
Photo 6: Westward view of high-calcium, marbled, laminated limestone of the Kinzer Formation exposed along Sherman Street. Steeply dipping surface on the left side of the outcrop is bedding.

Sherman Street just outside the quarry. Bedding measurements made in the east quarry wall and on the west side of Sherman Street outside the quarry were notably different and supported the location of the Gnatstown thrust fault where it is currently mapped. Bedding dip in the quarry was measured to be 19 degrees east, while bedding dip on Sherman Street was measured to be 67 degrees to the southeast. The southeast portion of the quarry wall was noticeably highly fractured, though no distinct fault plane was visible. Outcrops on Sherman Street appeared to be high calcium or marbled Kinzer limestone (Photos 6 and 7).

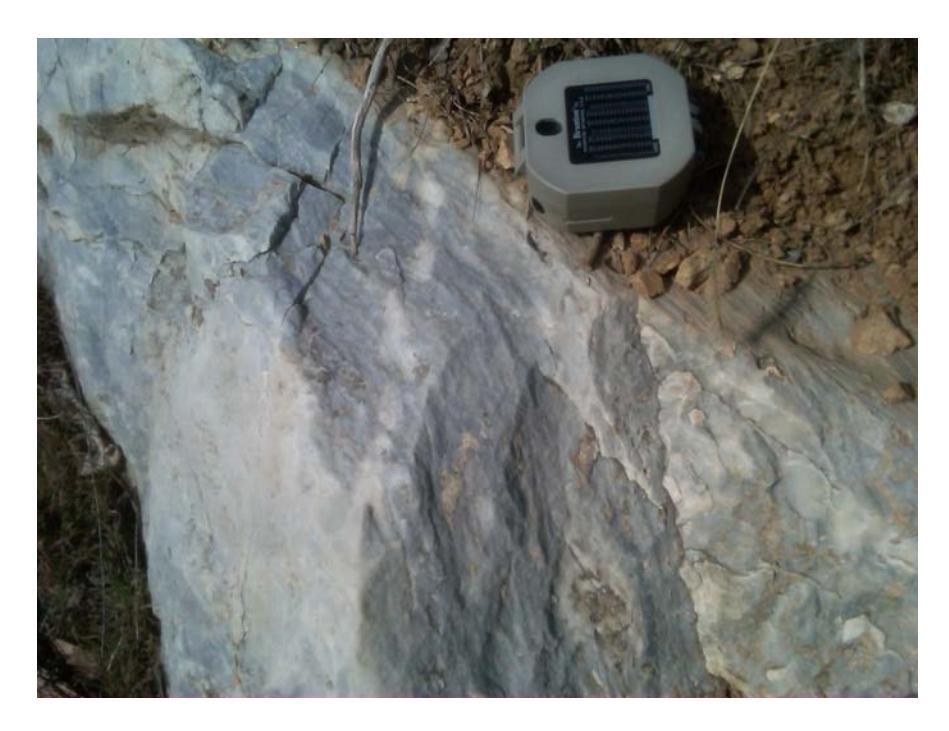
Photo 7: Westward and downward close-up view of the high-calcium, marbled, laminated Kinzer limestone exposed along Sherman Street. Laminated bedding is visible.

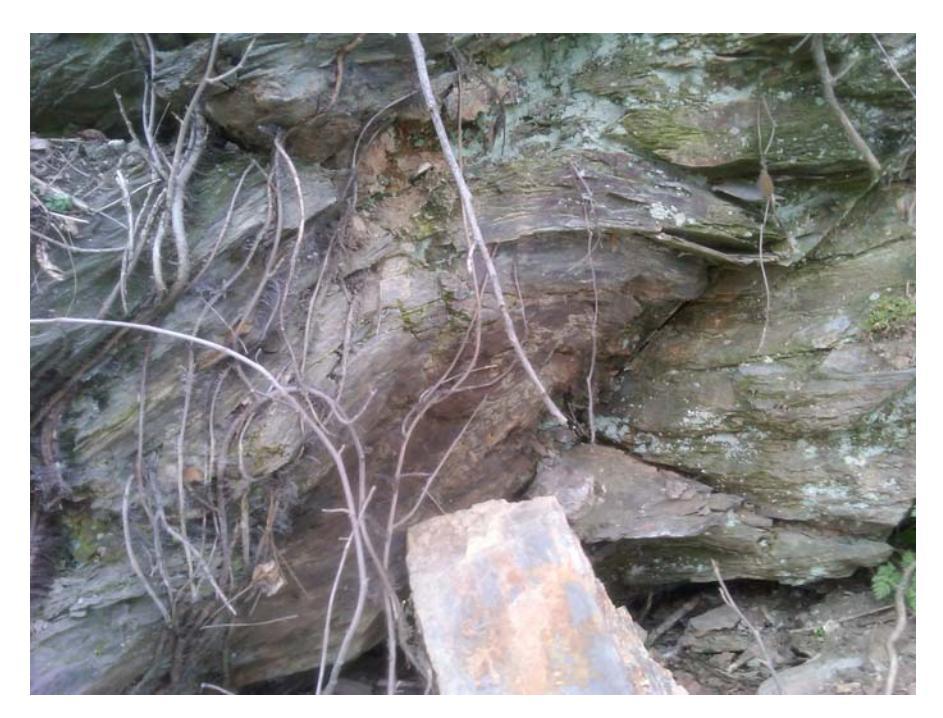
Photo 8: Westward view of Kinzer shale in outcrop along North George Street with an apparent drag fold adjacent to a small fault. General dip direction is to the south (left).

The Kinzer was also observed and measured in an adjacent fault block, northwest of the I-83 interchange along North George Street. Here the contact with the underlying Vintage was again observed, though not as well as along Toronita Street or Codorus Creek. The north end of an outcrop along North George Street exposed the knotty dolostone of the Vintage Formation that dipped southward under the Kinzer shale which was exposed over most of the outcrop (Photo 8). The contact was partially obscured in this area and the transitional beds were not visible. The bedrock measurements made in this outcrop required a slight adjustment to the orientation of the contact between the Vintage and Kinzer formations at the north end of the outcrop. It is uncertain whether the shale continues northward to the edge of the fault block at the North George Street interchange with I-83.
